ROAD CROSSINGS AS BARRIERS TO SMALL FISH IN VASCÃO RIVER

The first case of barrier removal and rehabilitation of fluvial continuity

Jorge Bochechas & Ana Cristina Cardoso

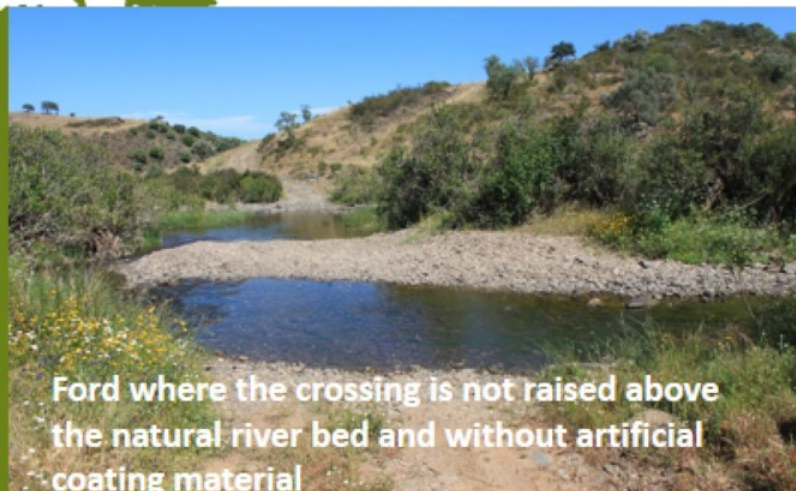
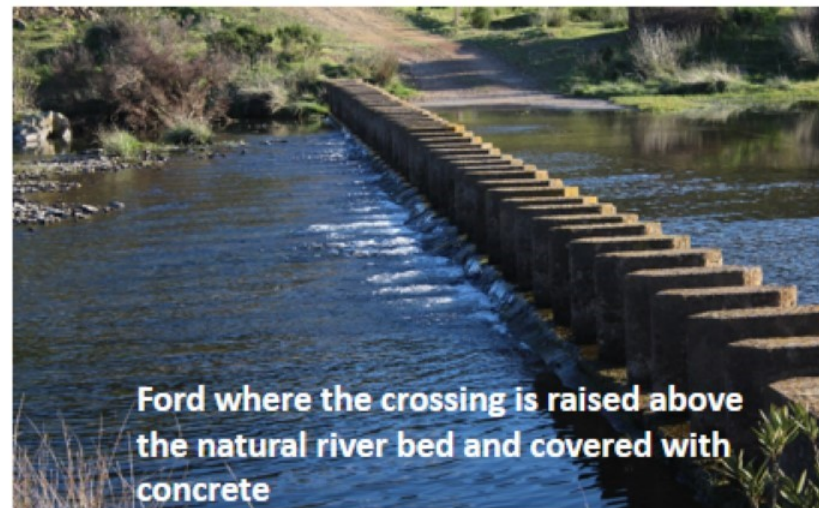
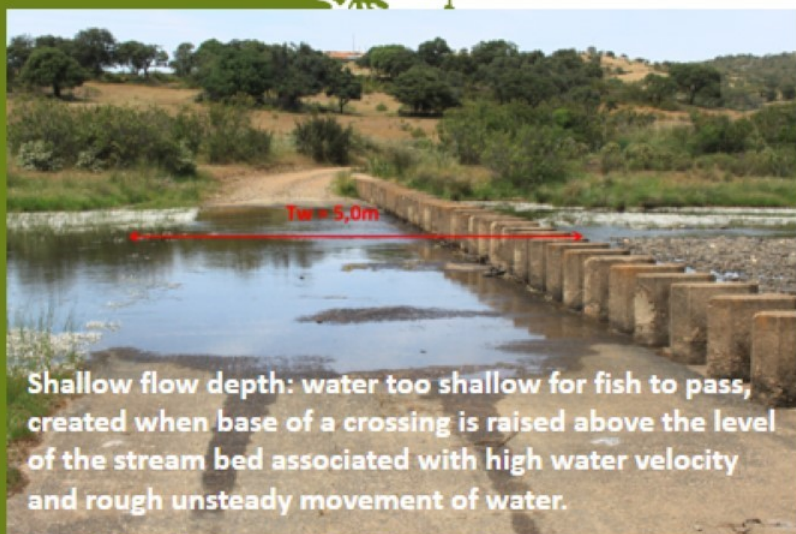
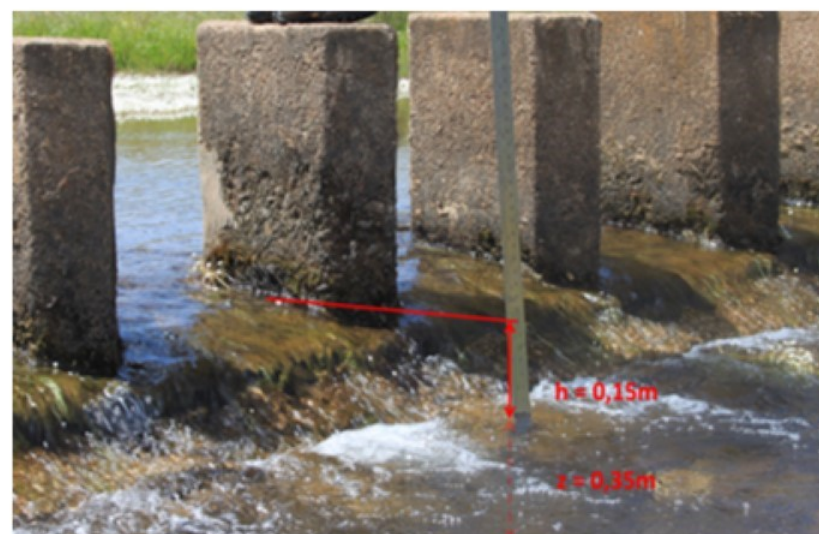
Why can't fish cross the road?

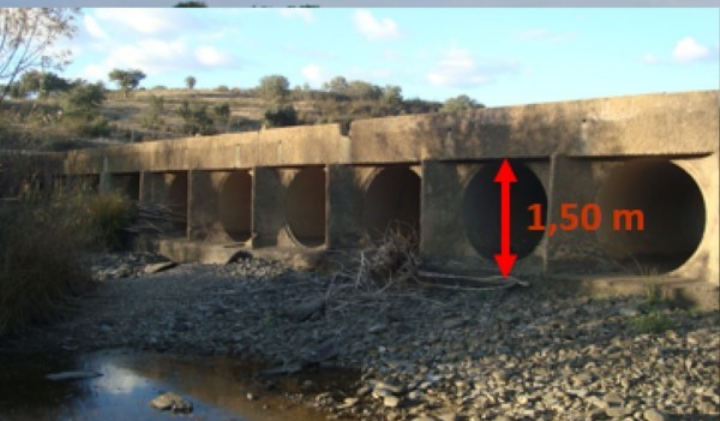
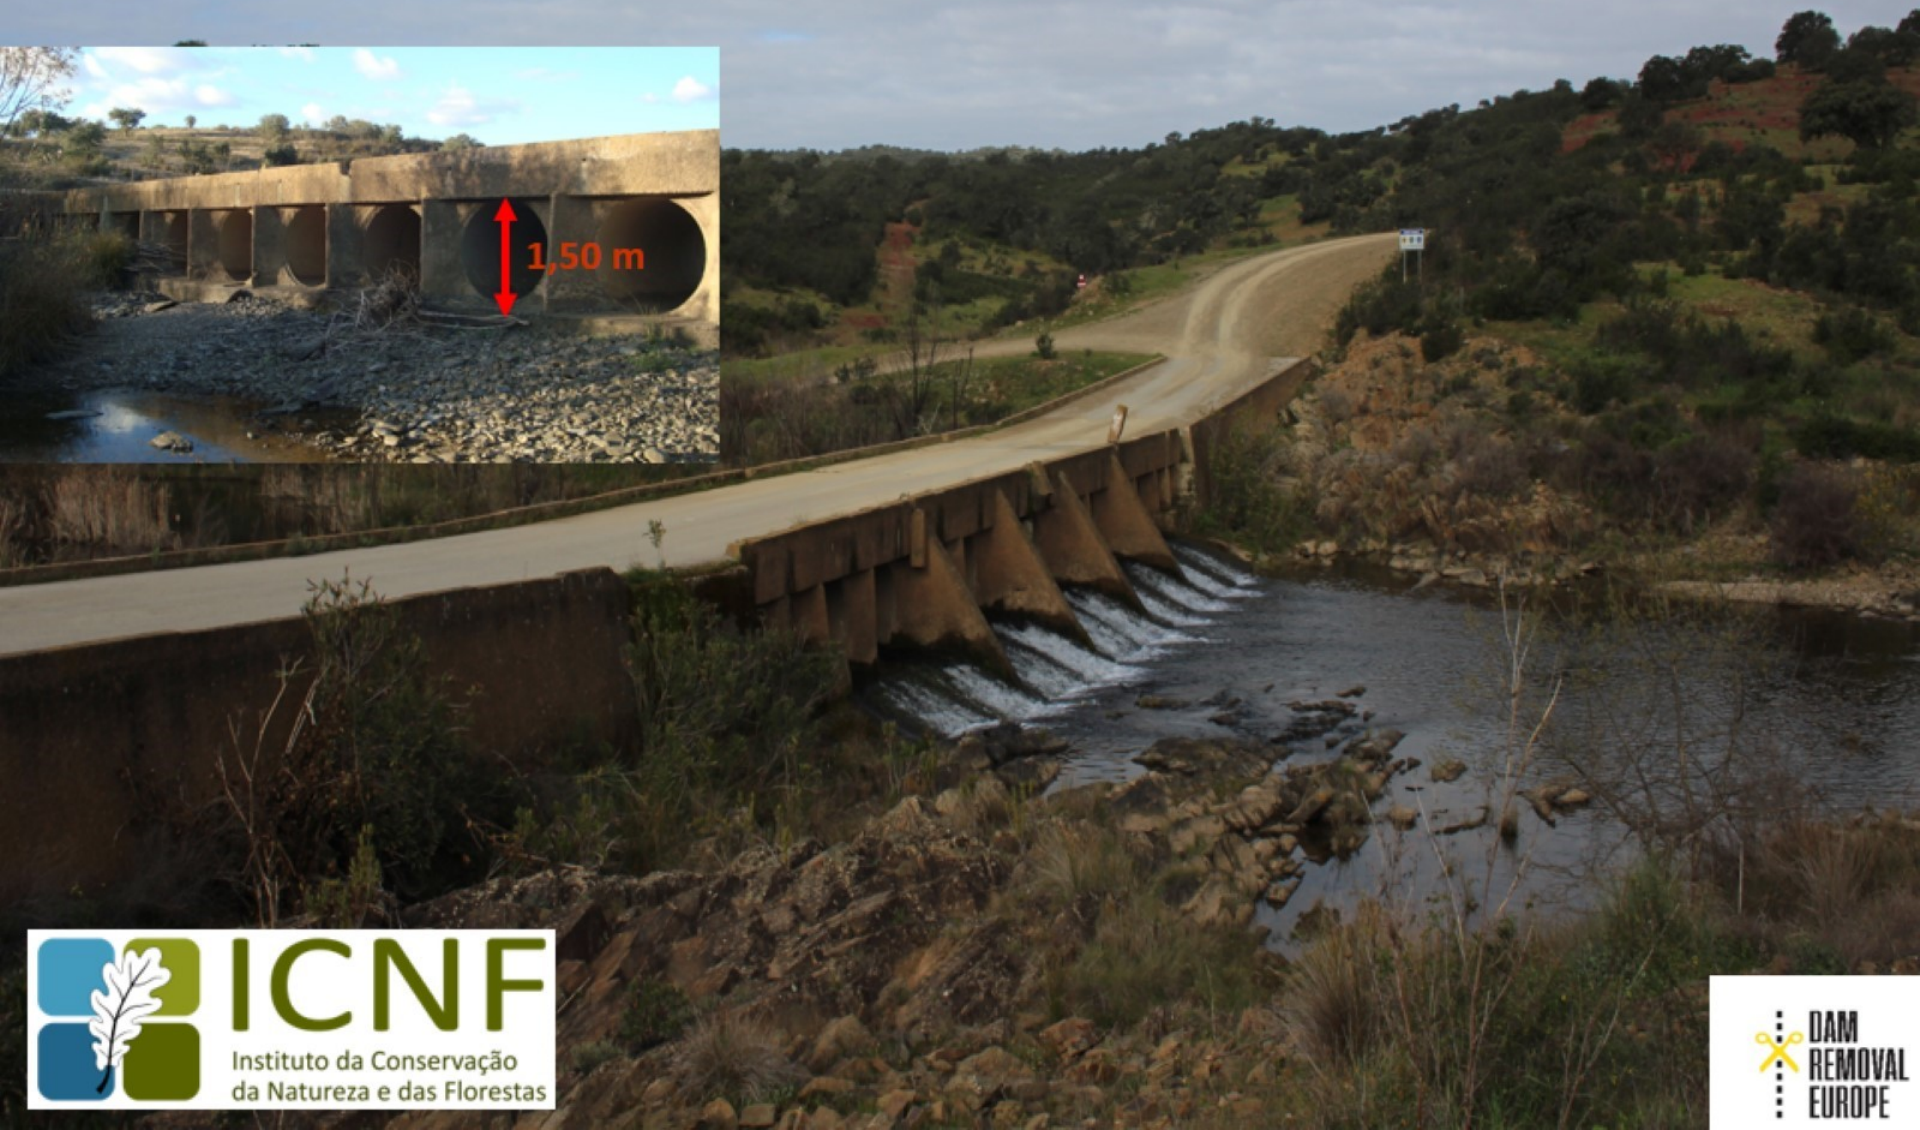
CNCF000014

CULVERT OF PESSEGUEIRO

In October 2021 the most important barrier for fish in Vascão river was removed
Replacement of part of the culverts by a bridge

The construction project was carried out by the national environmental agency
APA in accordance with ICNF guidelines
