DAM REMOVALS IN THE BASQUE COUNTRY

Dam Removals in the Basque Country

Inturia Dam Removal

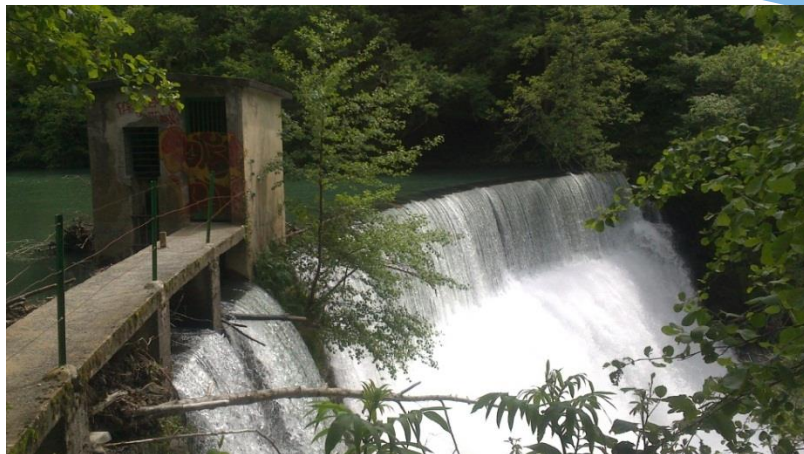
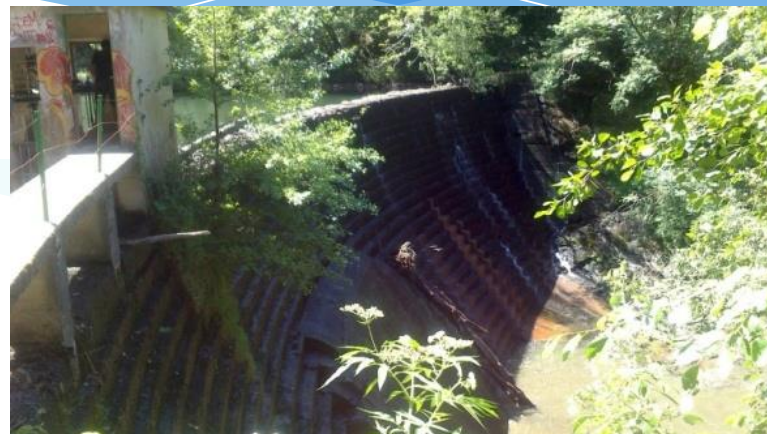
- **Largest dam** demolished in Basque Country: Height and volume of reservoir
- **On top of the dam:** Maneuver gate booth and 4 gates channelling water to a single collector, (outflowing at the foot of the dam).
- **REASONS FOR ACTION:**
 - Insecure infrastructure
 - Not in use
 - High maintenance costs
 - An industrial ruin
 - An obstacle for the river
 - An obstacle for the fish

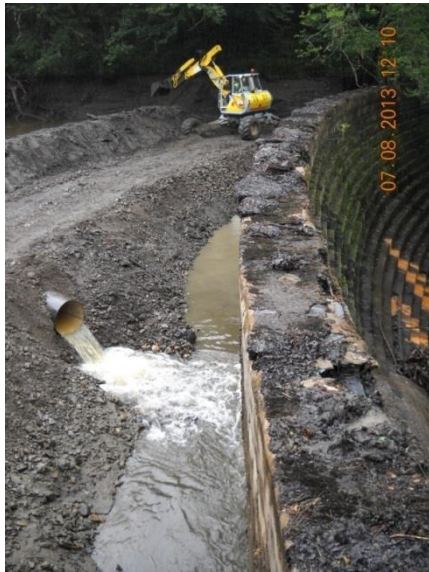
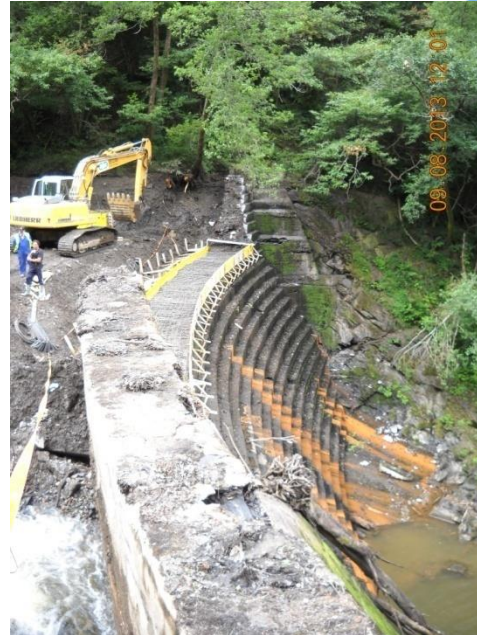
▪ Demolition of the left half:

- $H = 3.6 \text{ m}$
- Dam in poor condition
- Concrete slab built

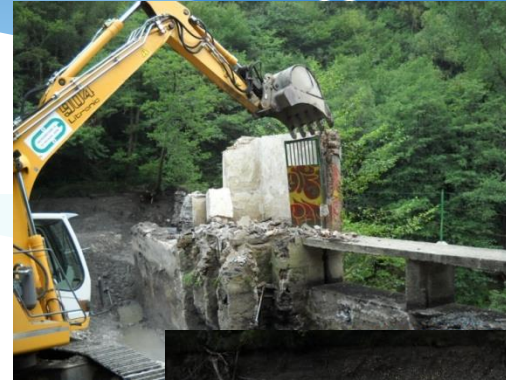
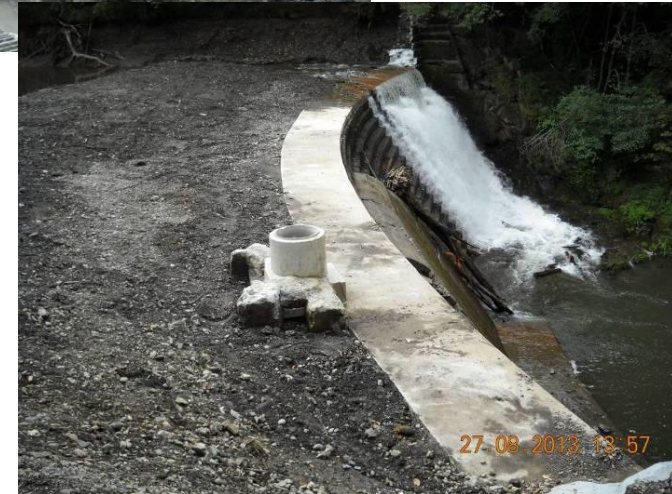
▪ Demolition of the right half:

- Water diverted via the left bank
- Concrete slab built

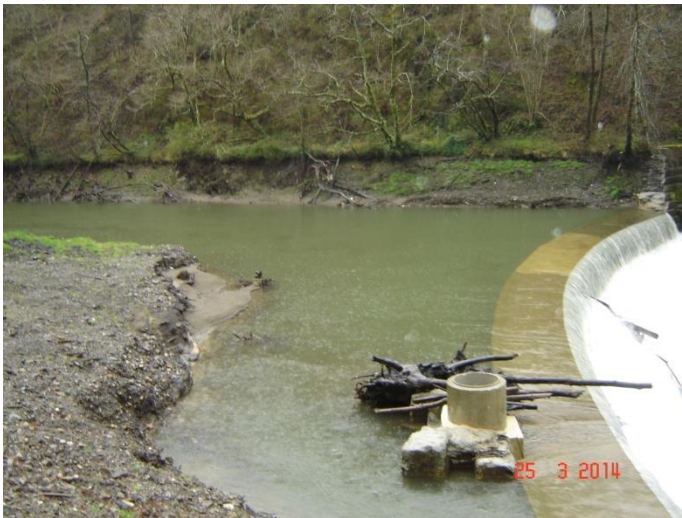
- Vegetation returns to the shore

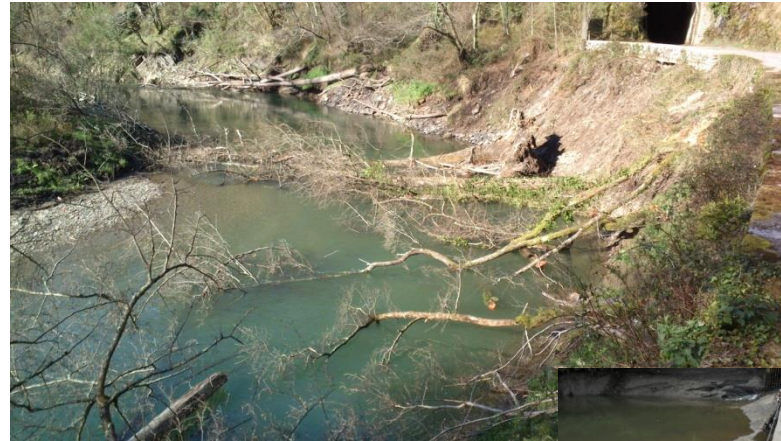
- Trees fall down

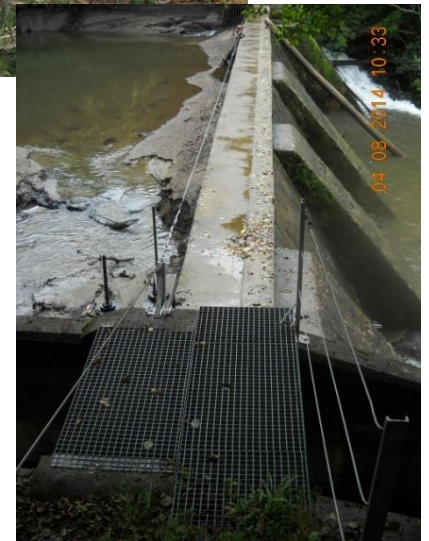
- Sediment carried downstream

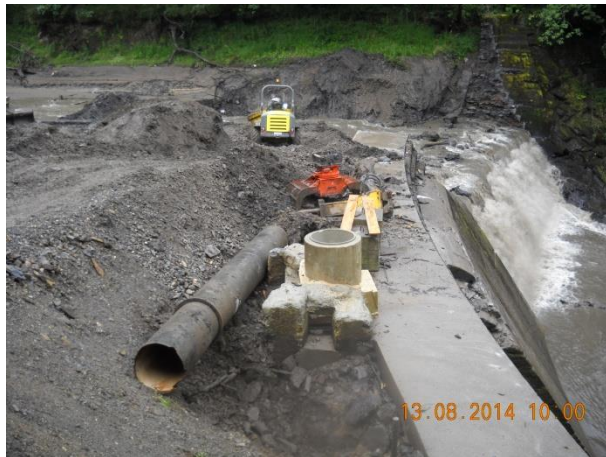
- **Problem:** Early hours of August 13:
a peak flow of 6.6 m³/s was registered
 - It takes with it the working platform
- New access built

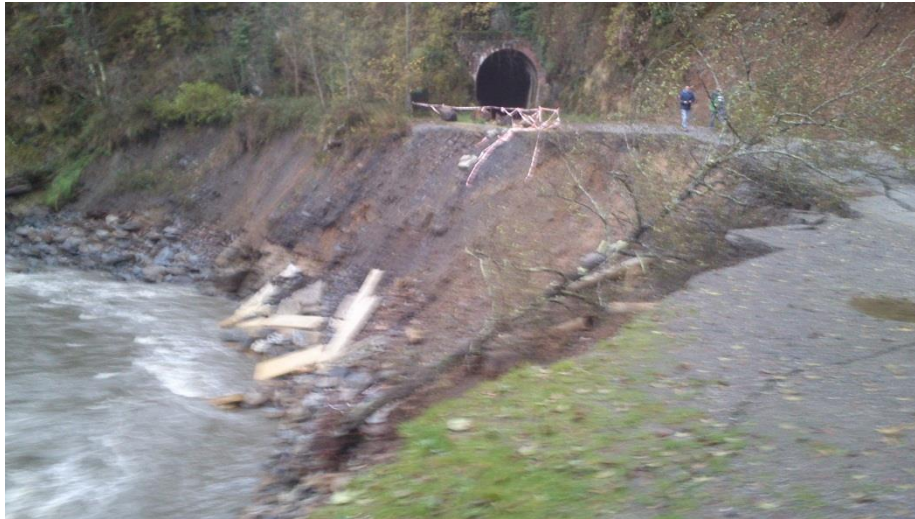
- **November 2015:** the river increases its flow from 3 to 139 m³/s (a five-year flow in one day)

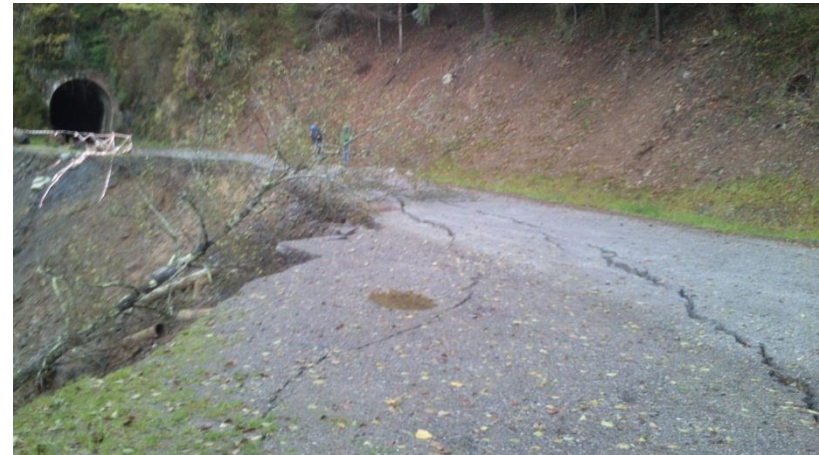
- 250 m upstream the wall supporting a local road slides and collapses

- It was decided to advance the demolition to January, in order for the water level upstream to reach its final level
- Only then could the river bank be stabilized
