DAM REMOVALS IN BASQUE COUNTRY Basque Water Agency (URA)

Pärnu, 22nd may 2019

INTURIA DAM

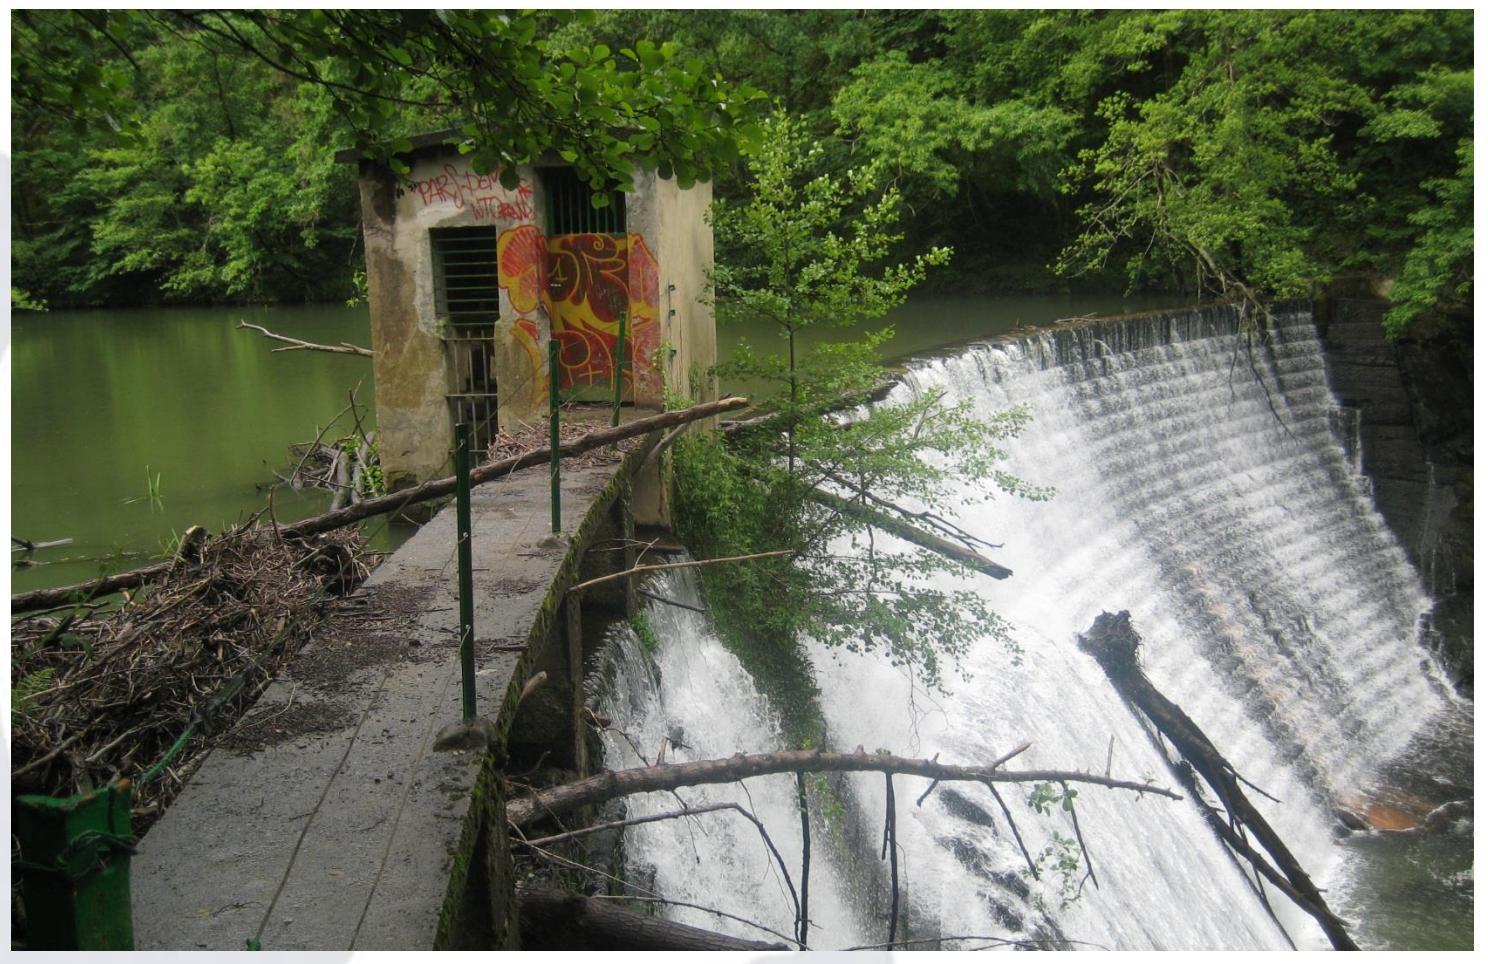
INTURIA DAM

- Deteriorated structure in disuse.
- High cost of maintenance.
- Fauna barrier and hydromorphological disturbances.

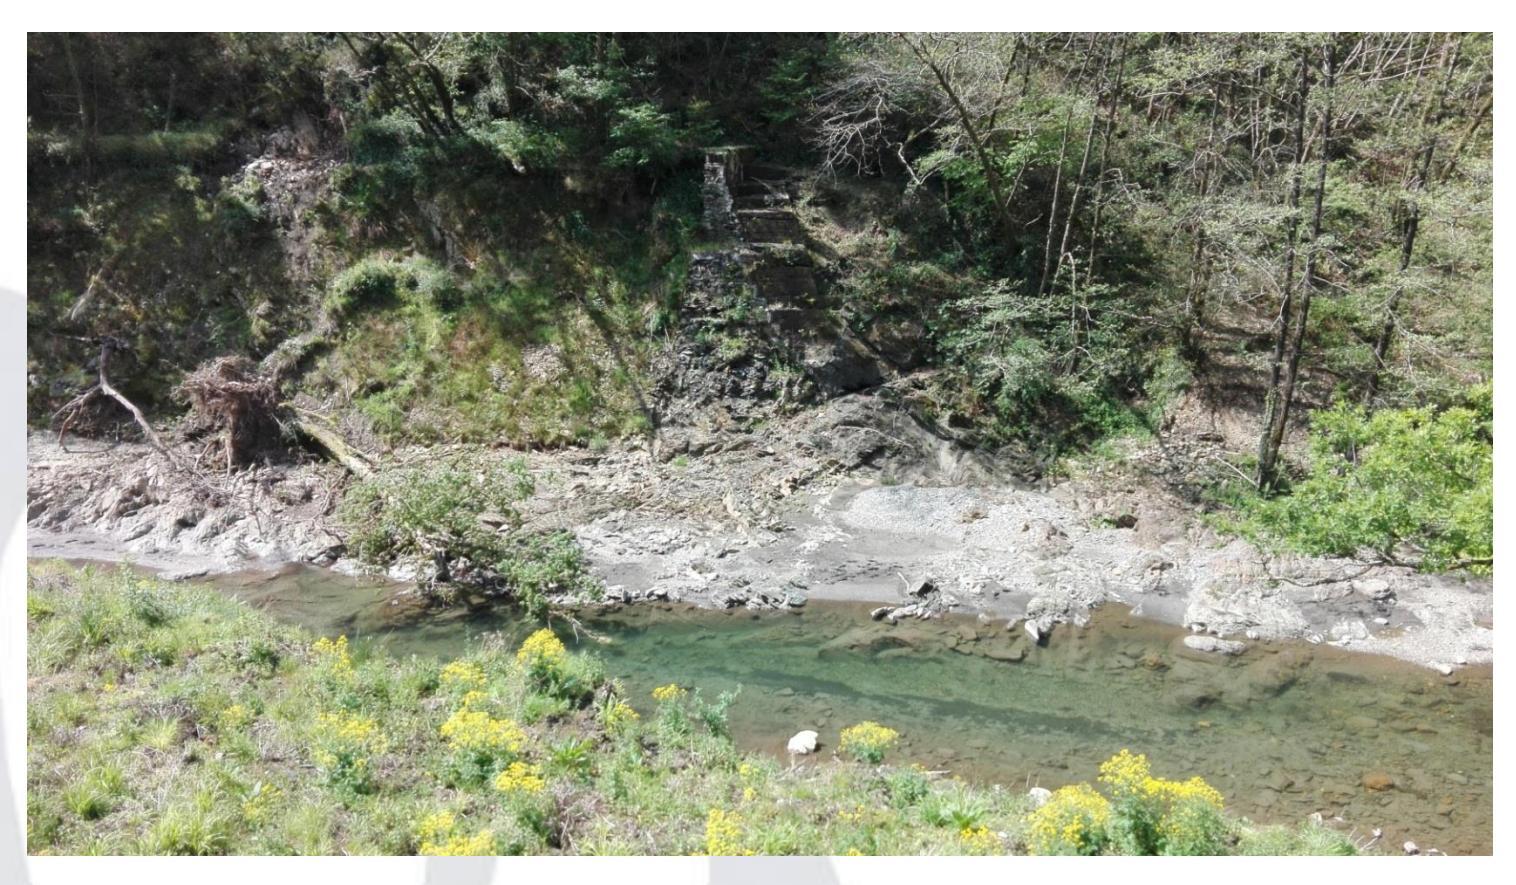
<u>GEOMORPHOLOGICAL</u>: Upstream of the former backwater area, there have been significant incisions since the beginning of the demolition, but in the last two years have slowed down.

<u>SEDIMENT TRANSPORT:</u> 240,000 m3 of sediments have been released from Inturia dam. 66,600 m3 of suspended sediments have been washed downstream, 28% of which passed through the gauging station.

HABITATS (meso-habitat, section of 4.5 km fluvial): The study section corresponds to a fluvial salmonid course where it's been confirmed that the productive areas have increased in number and length after the demolition.
