Medieval Weir Removal in UK

How to deconstruct ancient history

Dovecliff Weir

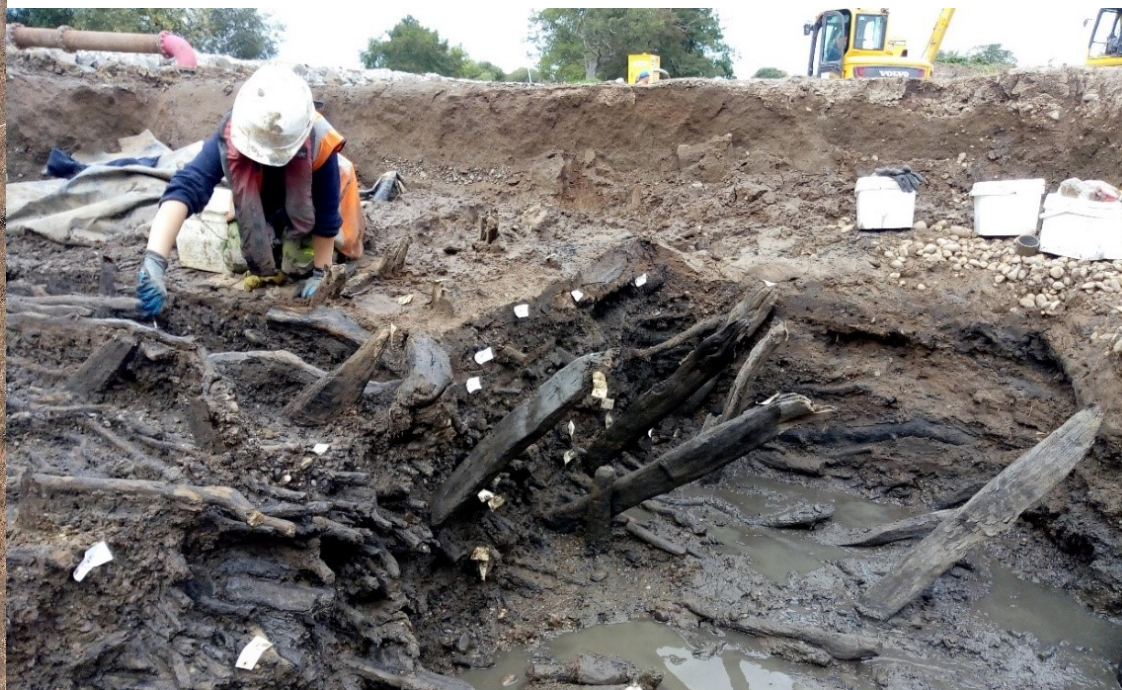
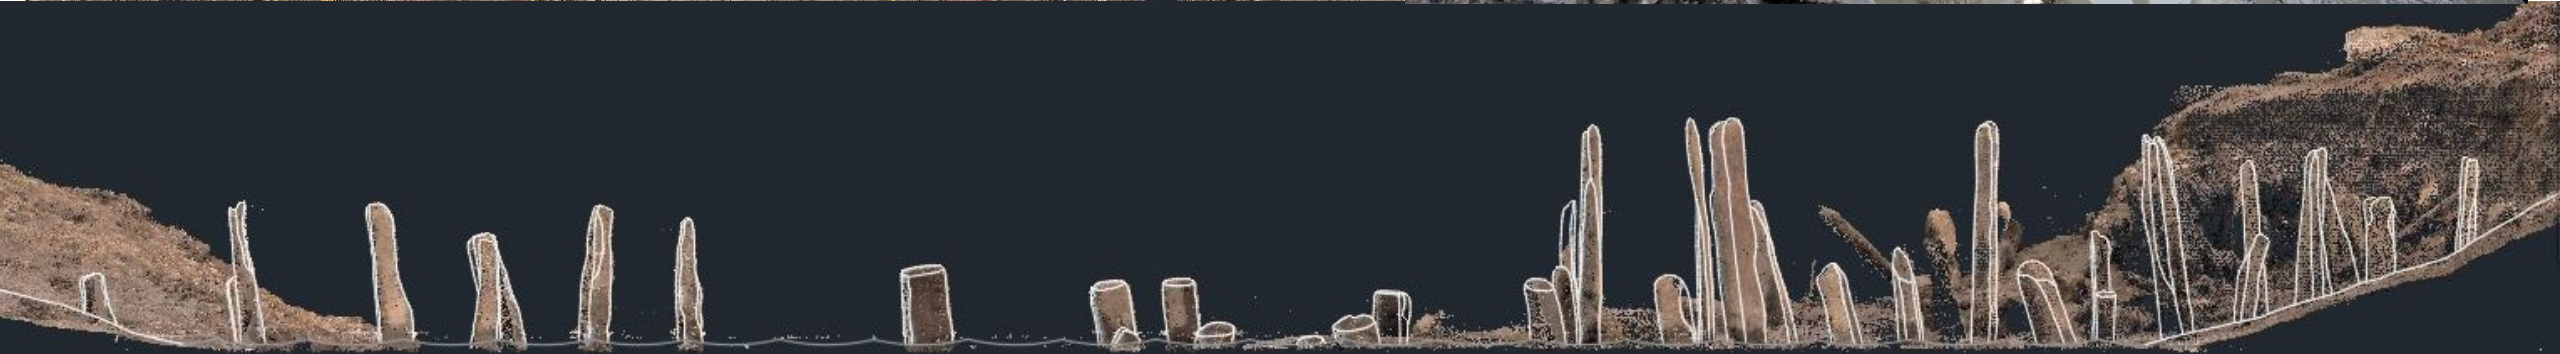
Bypass Channel

Timbers found within temporary bypass channel

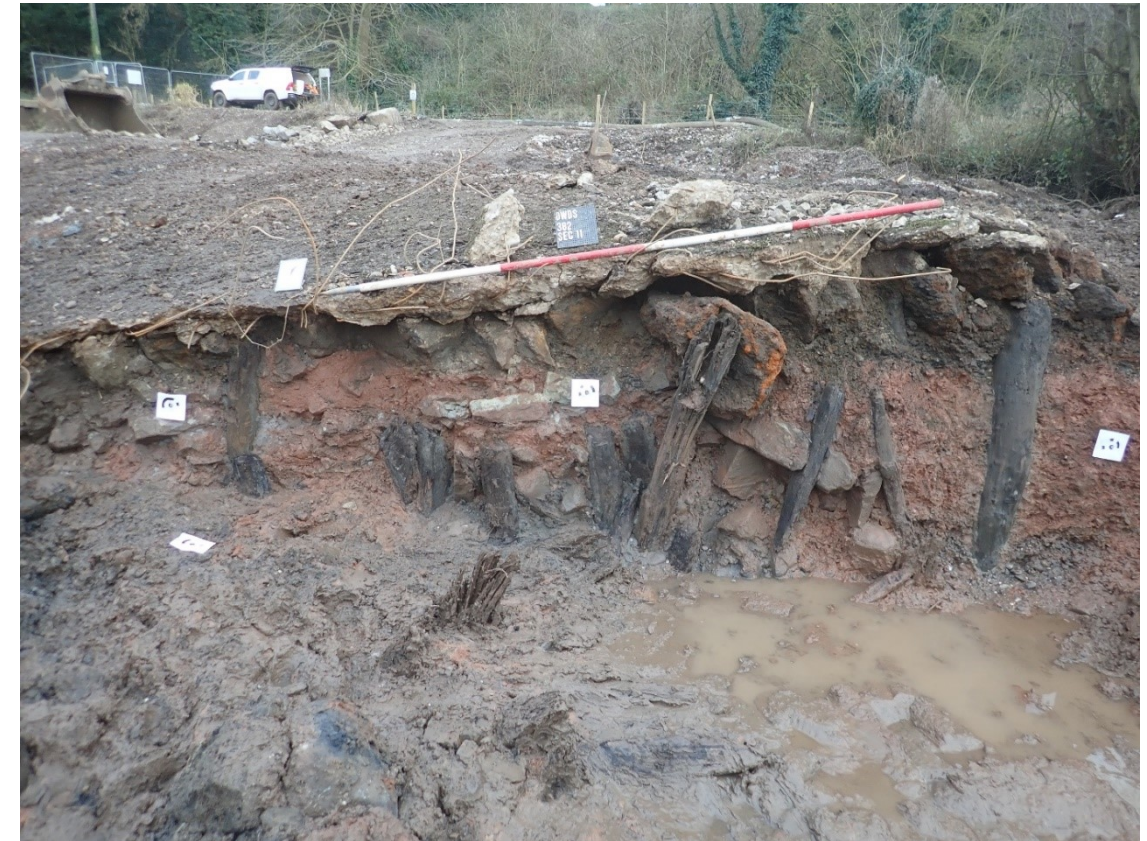
Construction

Timbers revealed during archaeological monitoring
