Lessons learned from the removal of the Krebsbach Dam in Germany

Dam Removal Goes Alps 2021, 06.05.2021
Ercan Ayboga

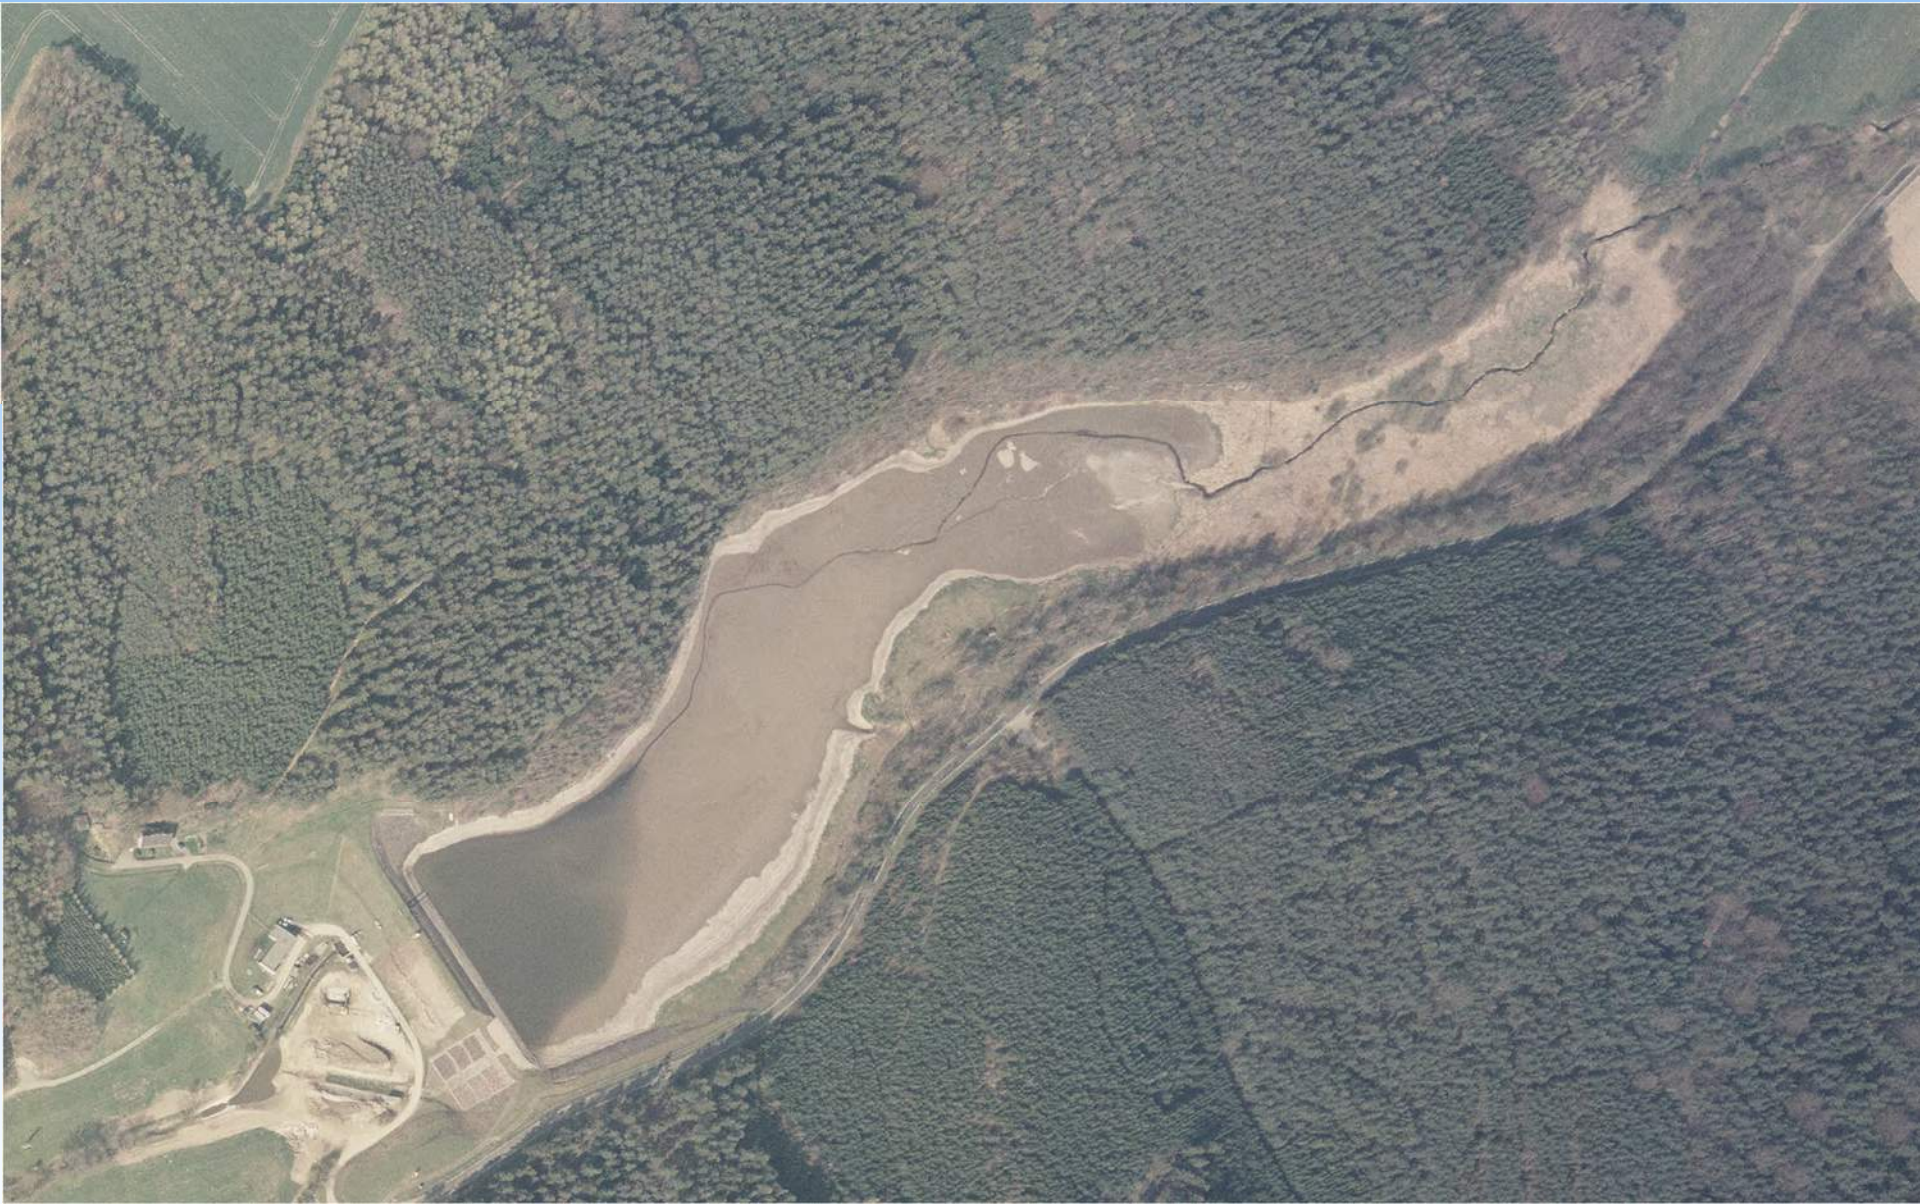
Situation after emptying reservoir, before the removal

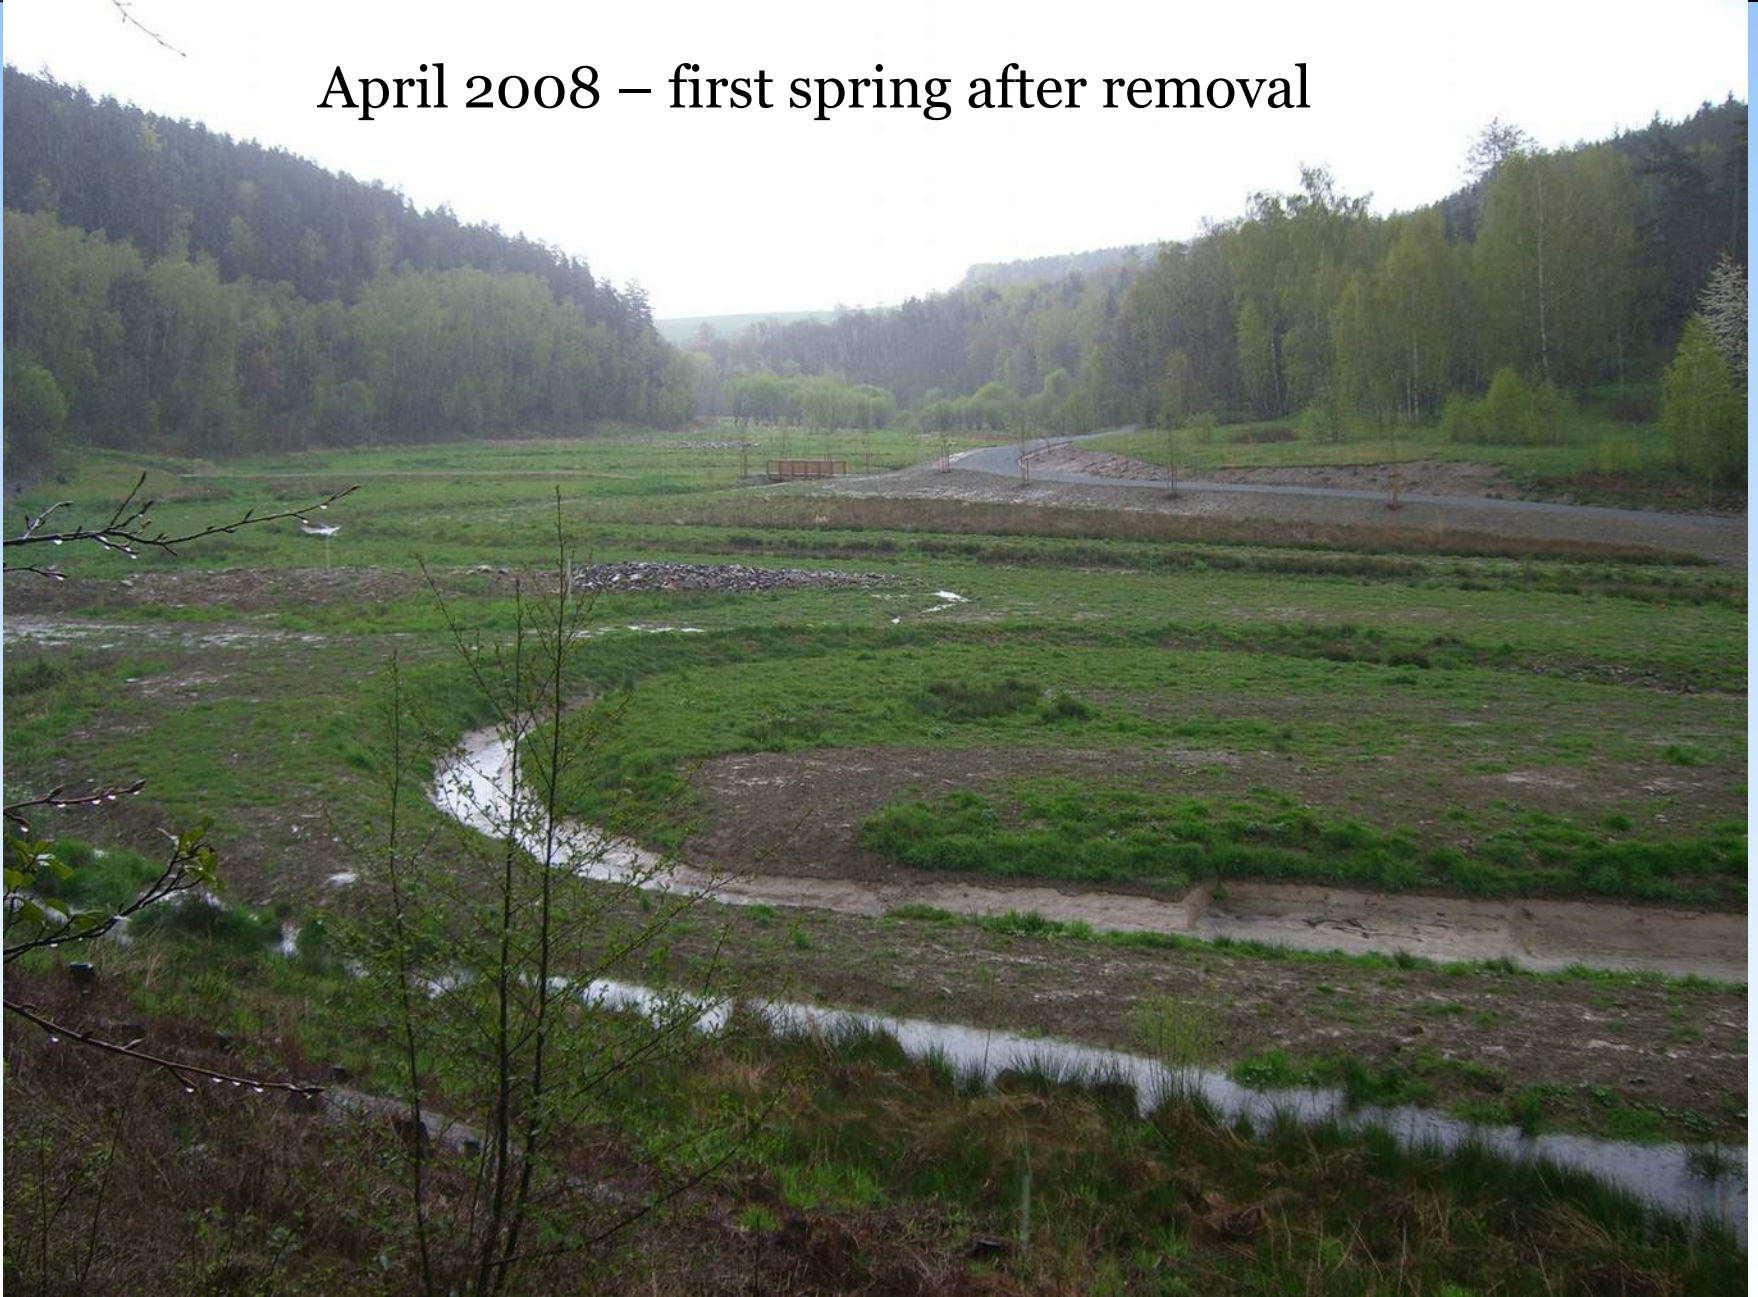
April 2008 – first spring after removal

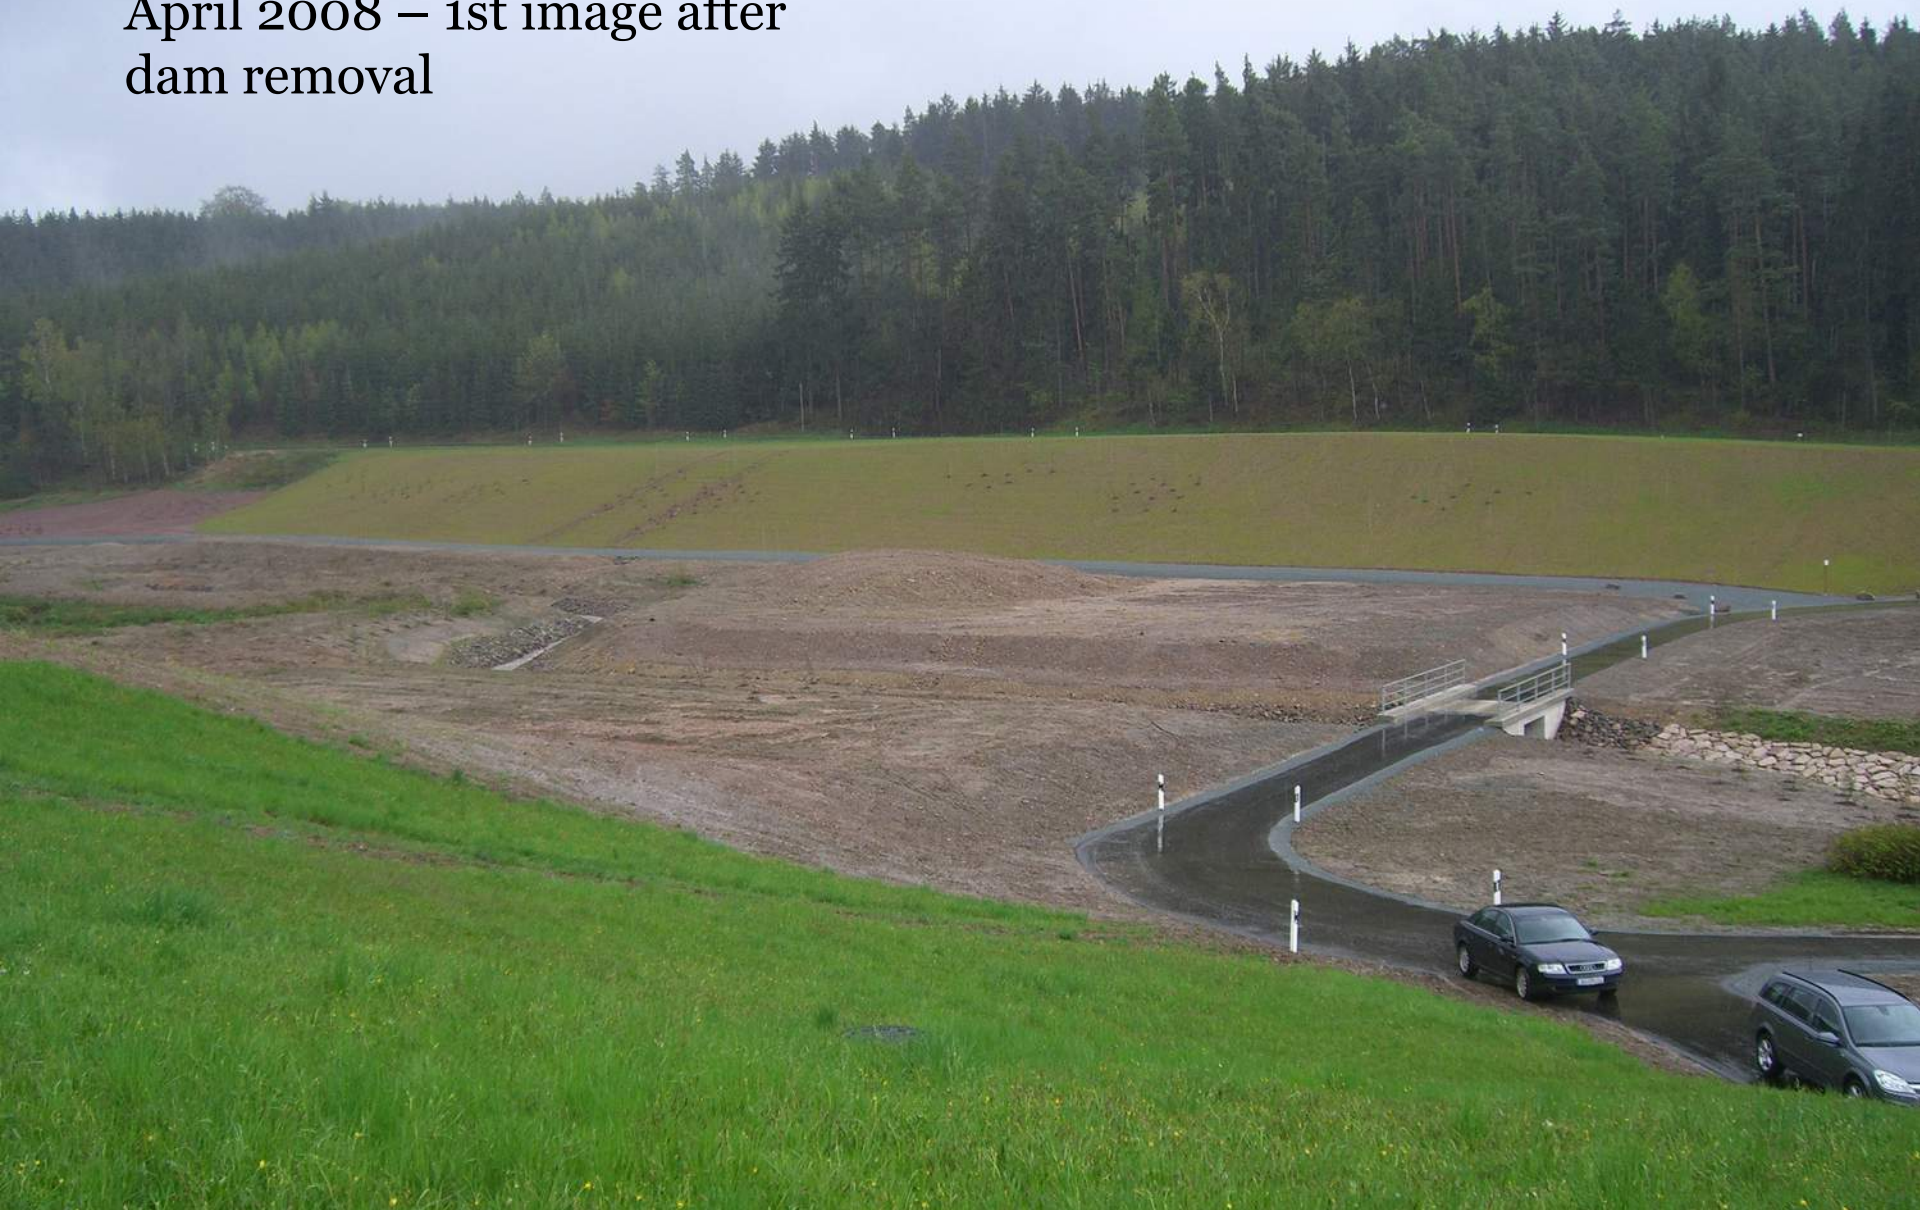
April 2008 – 1st image after
dam removal

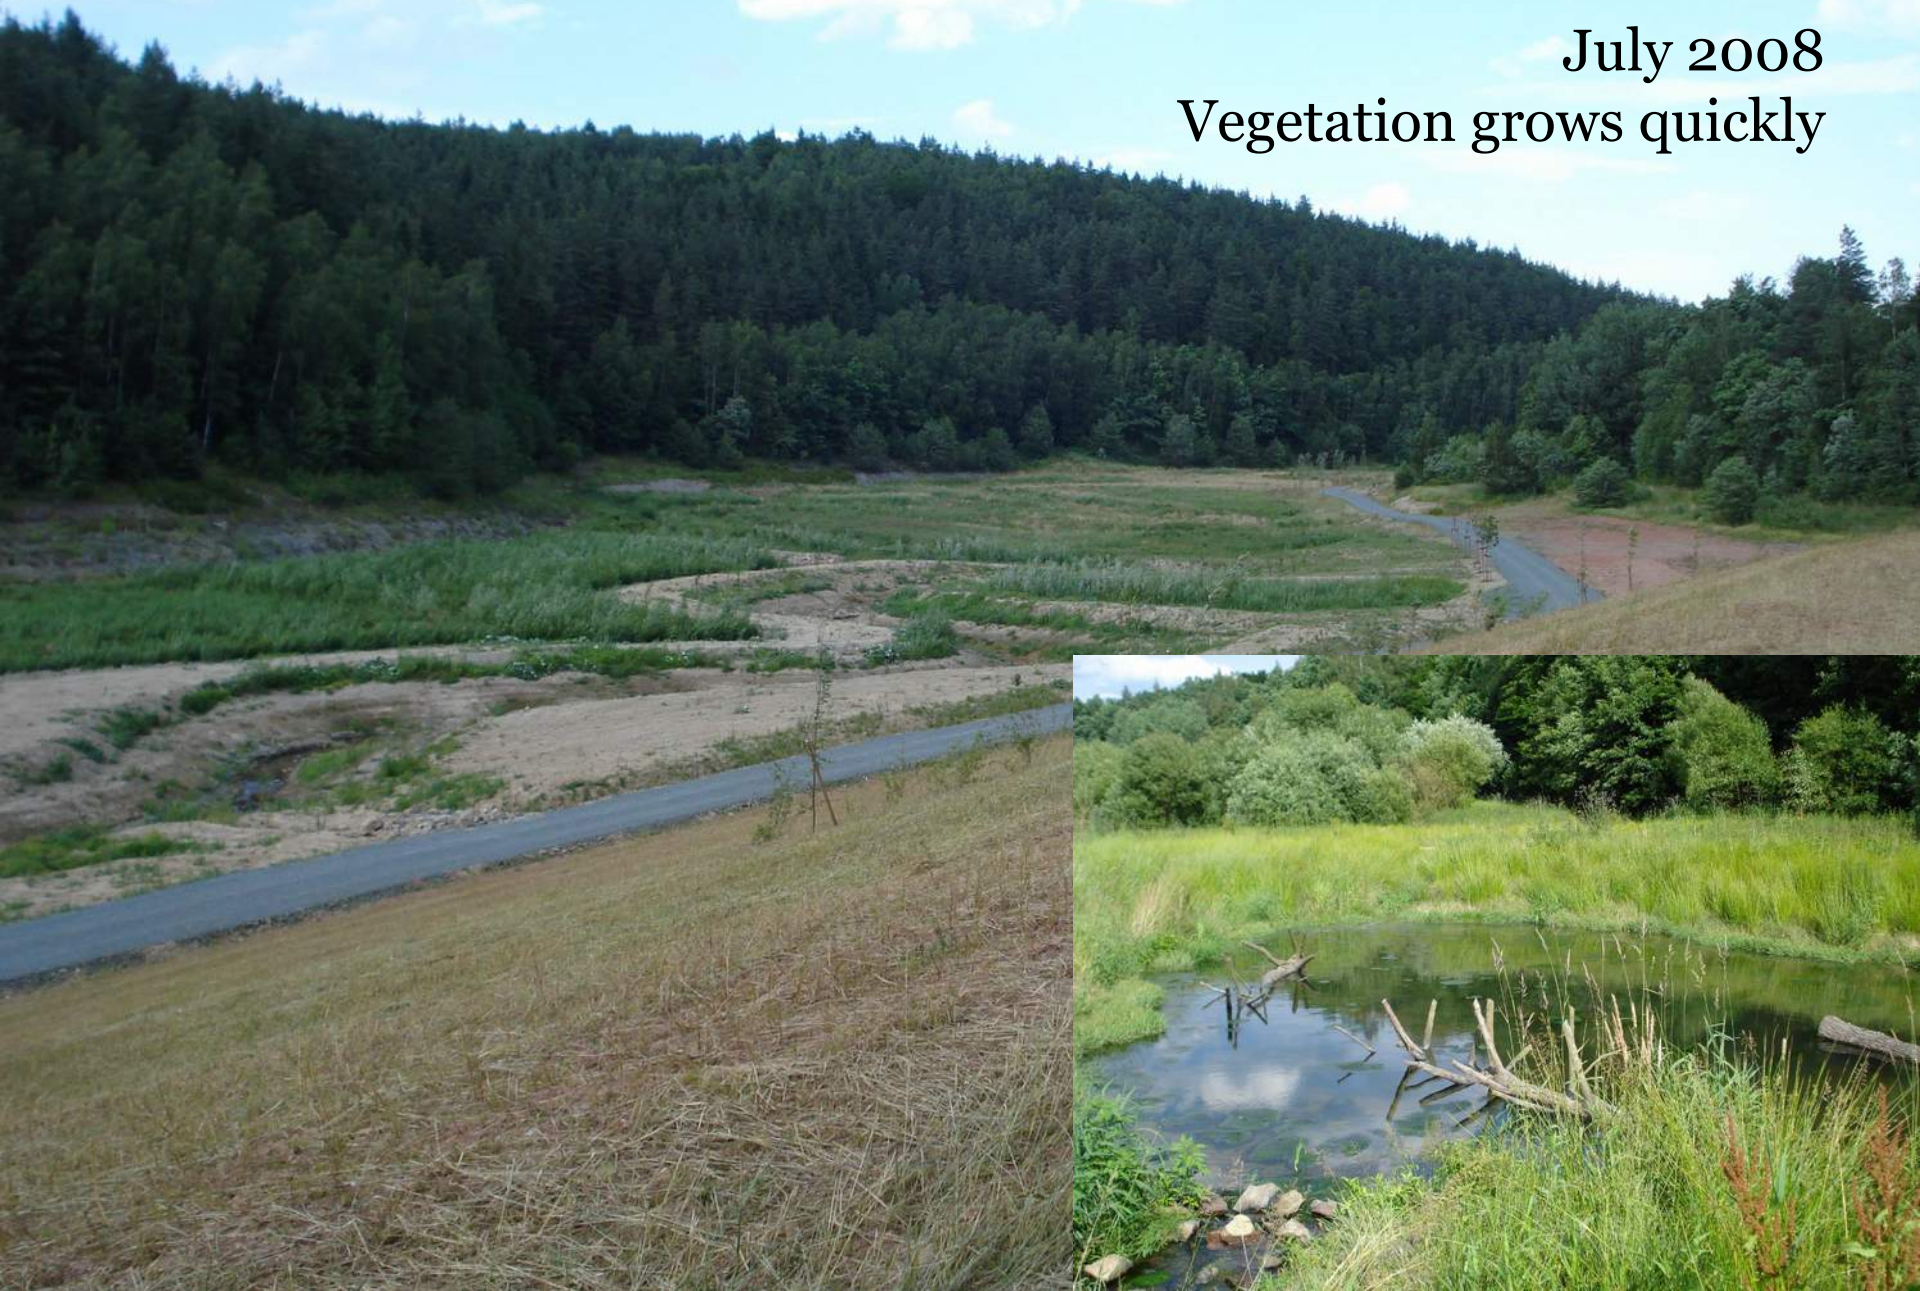
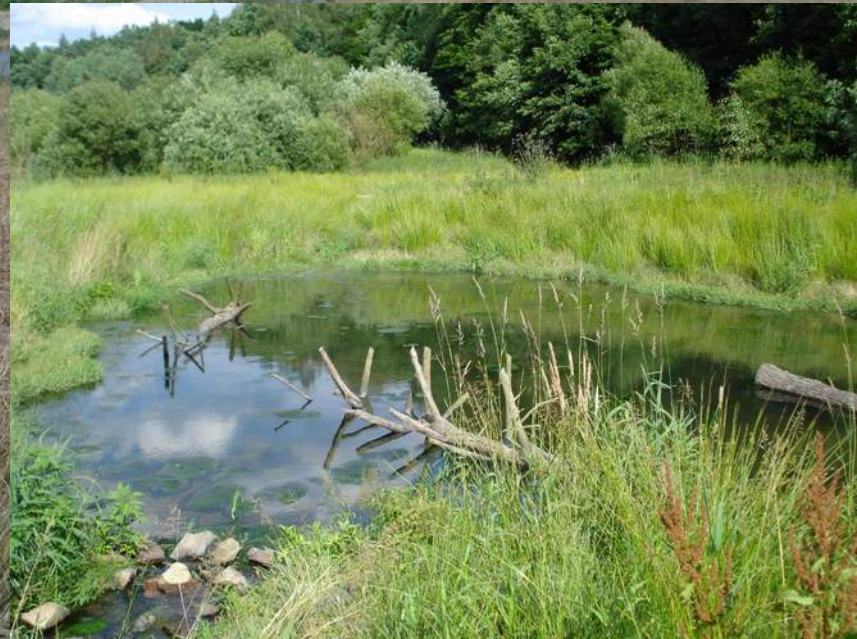
July 2008

Vegetation grows quickly

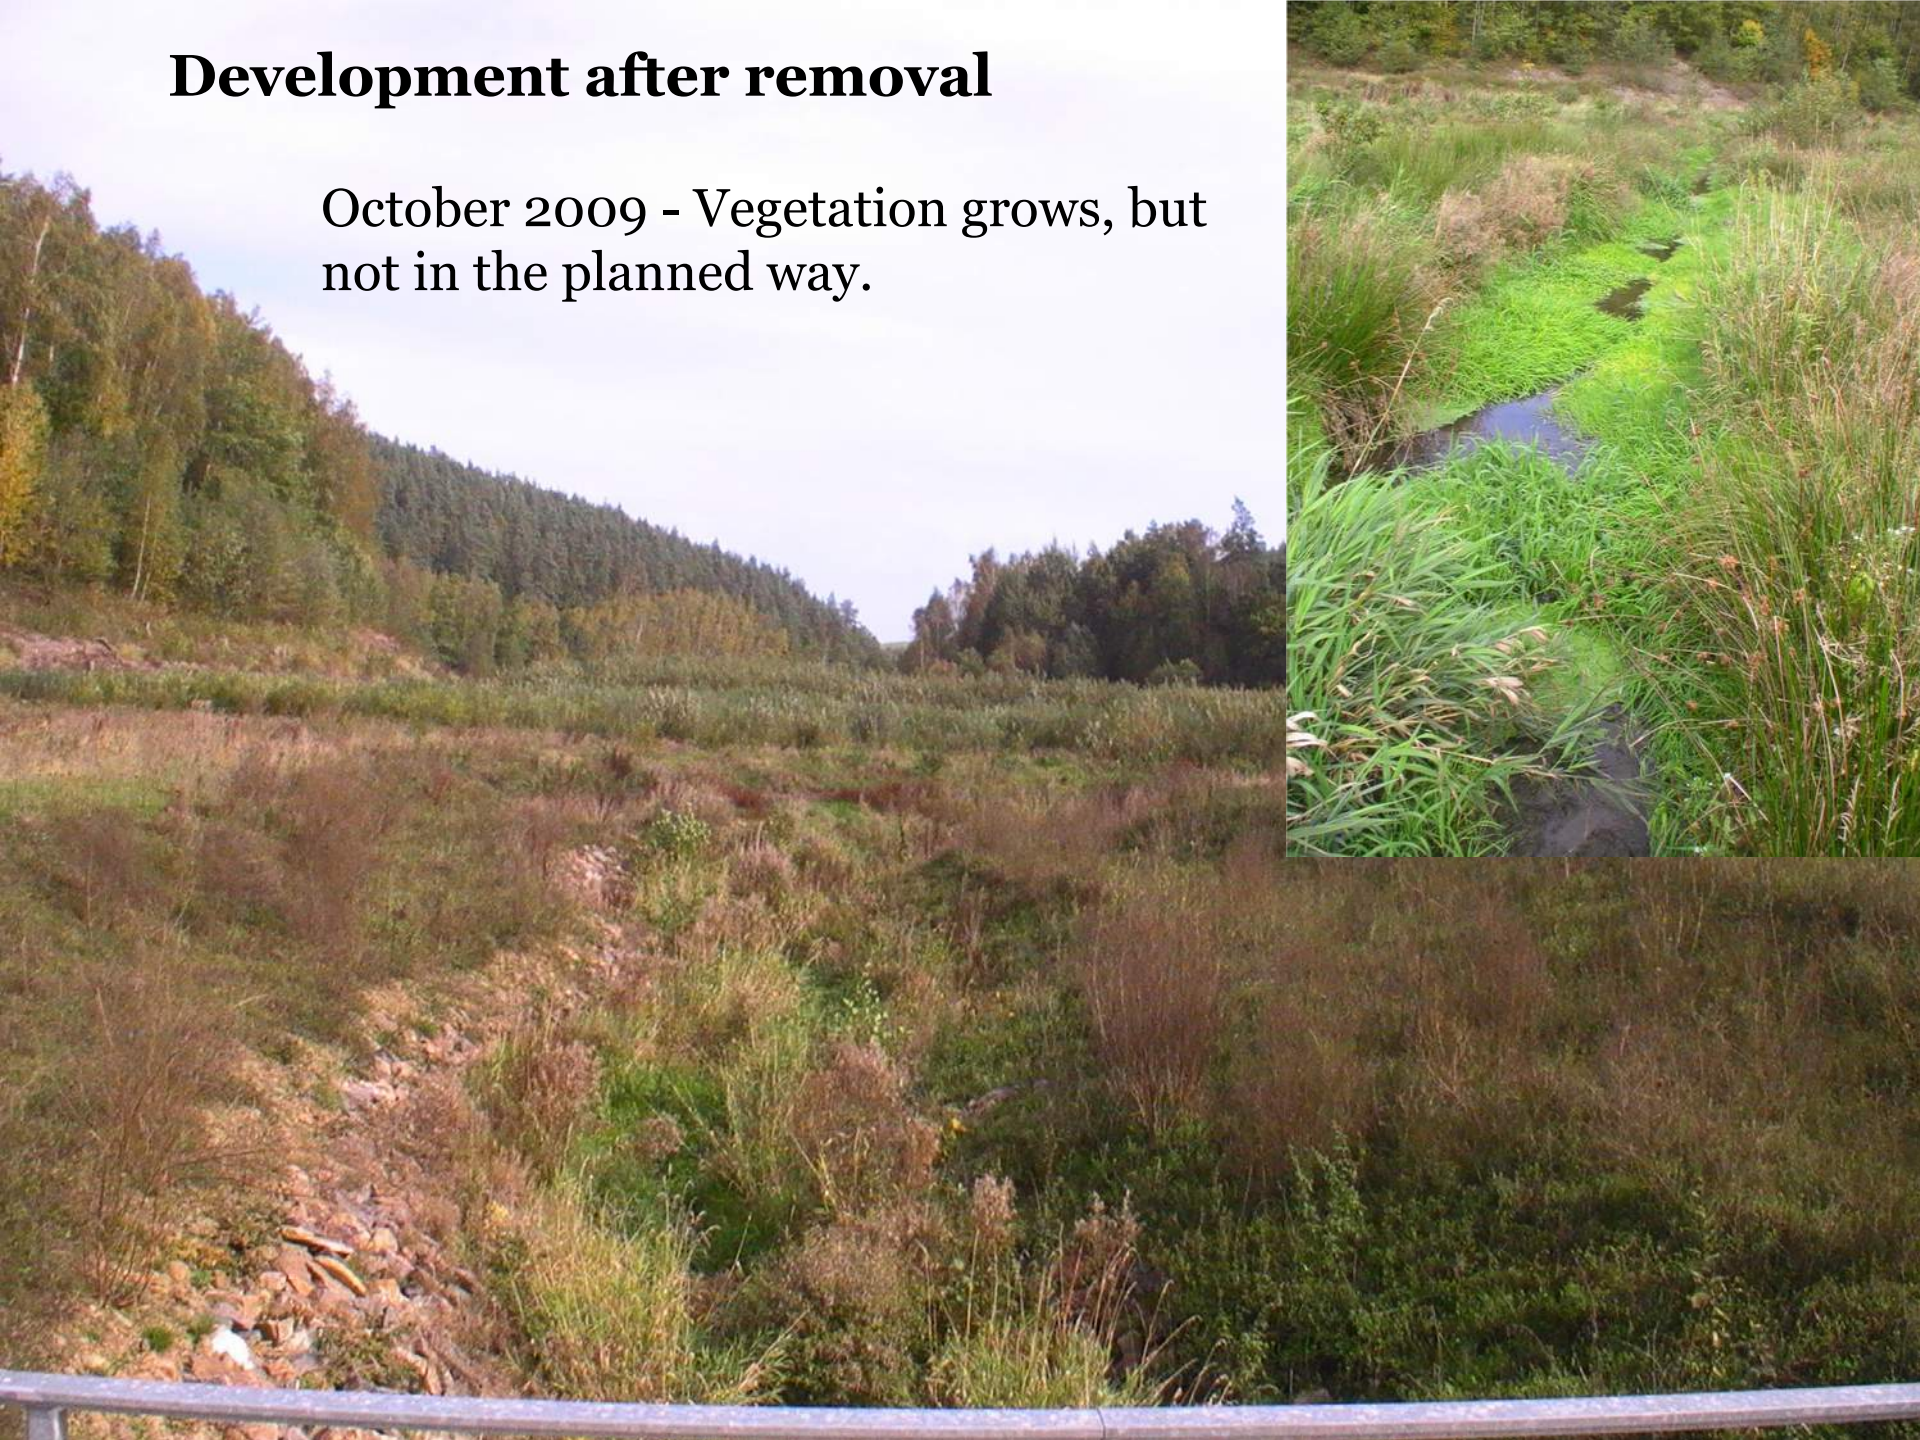
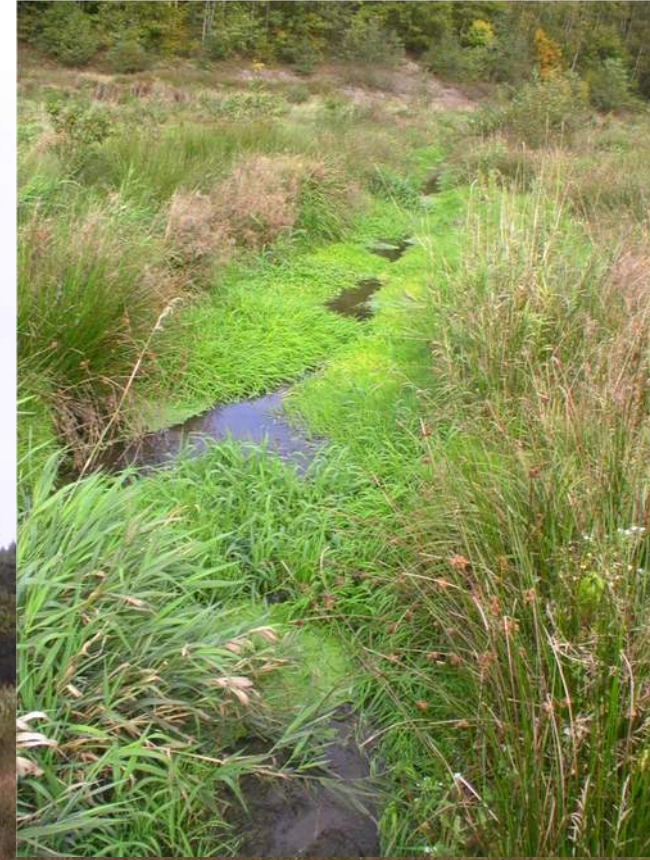
October 2009 - Vegetation grows, but not in the planned way.

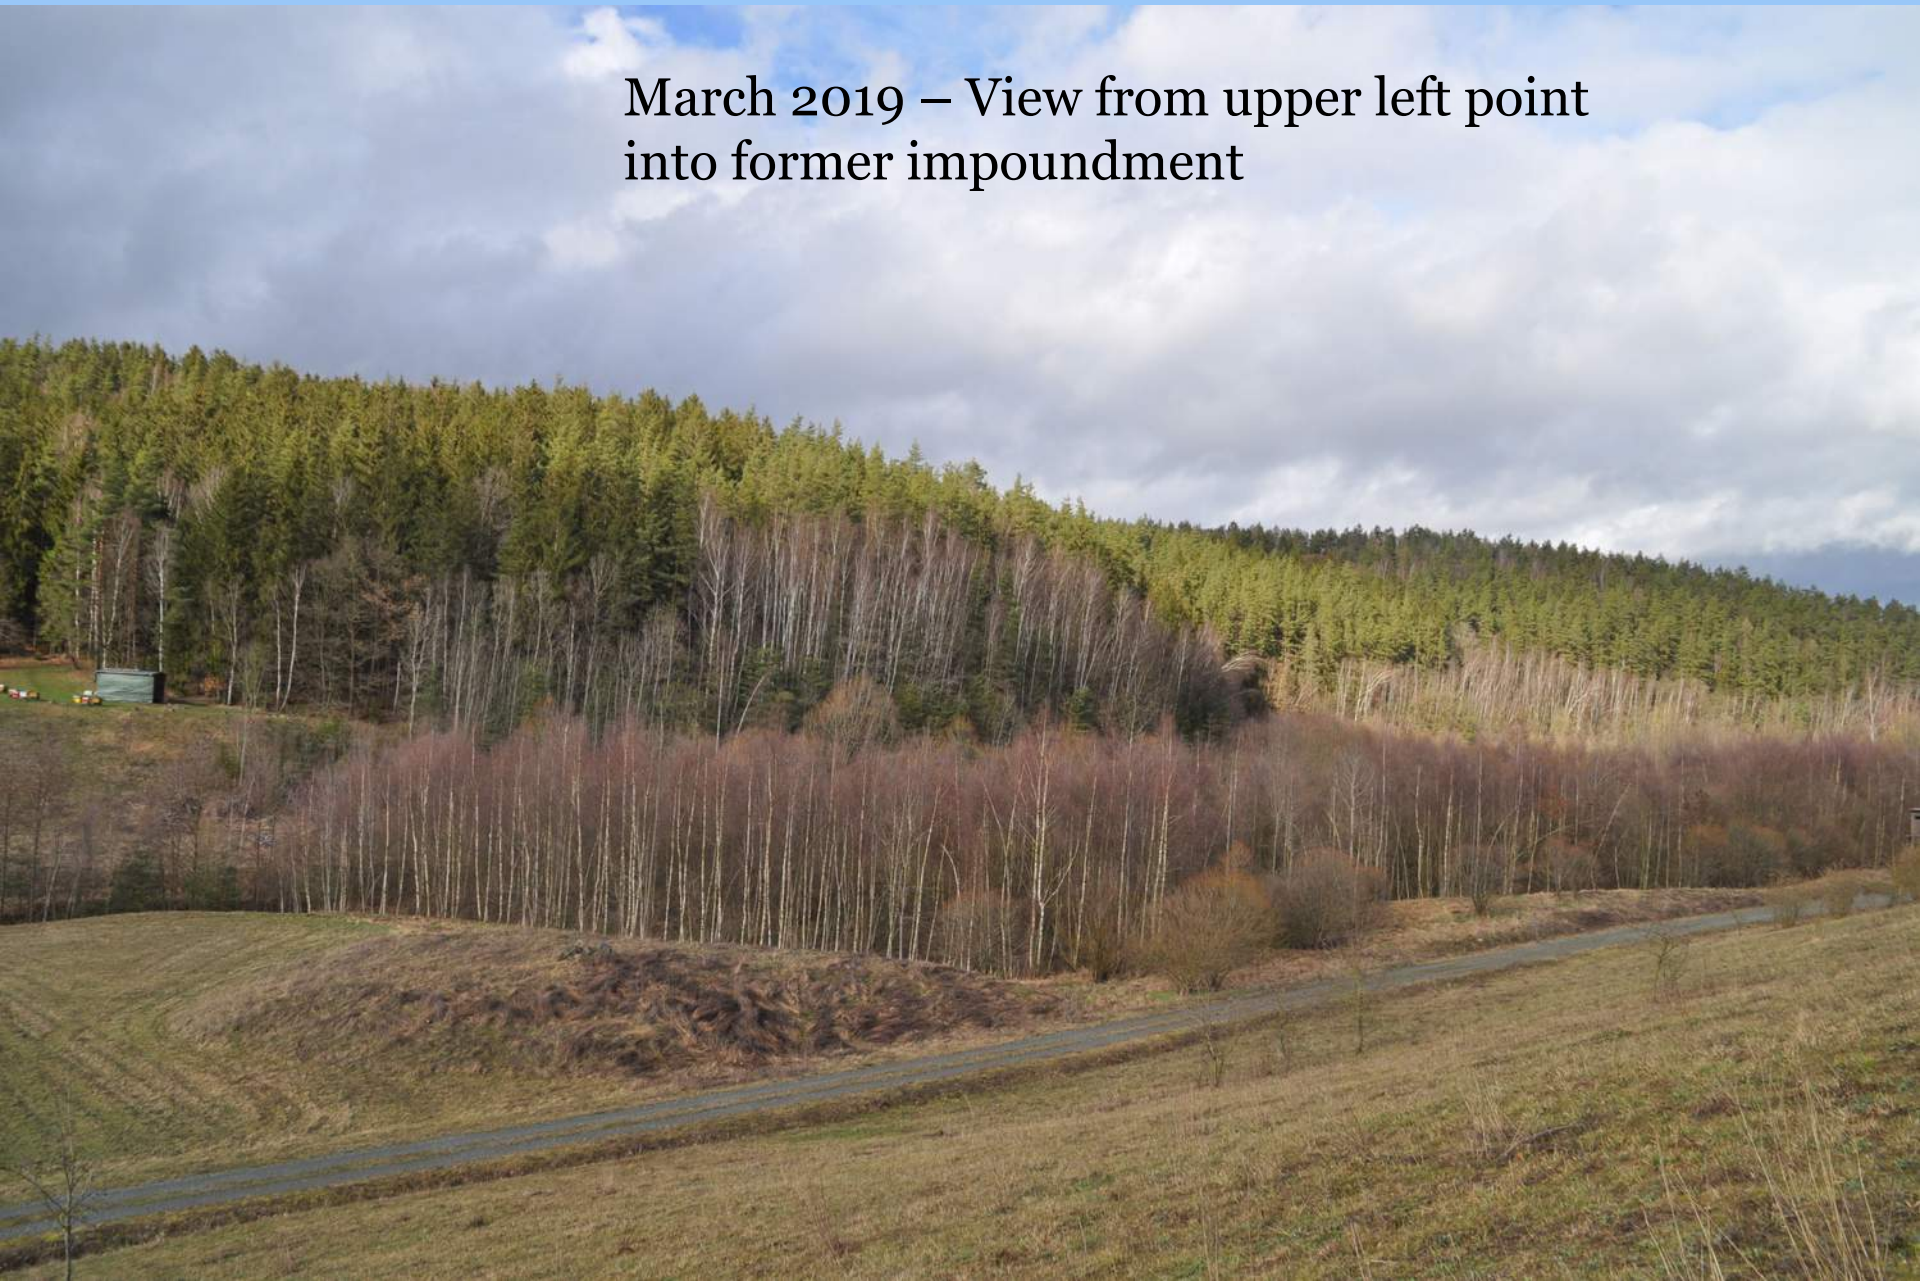
March 2019 – View from upper left point
into former impoundment

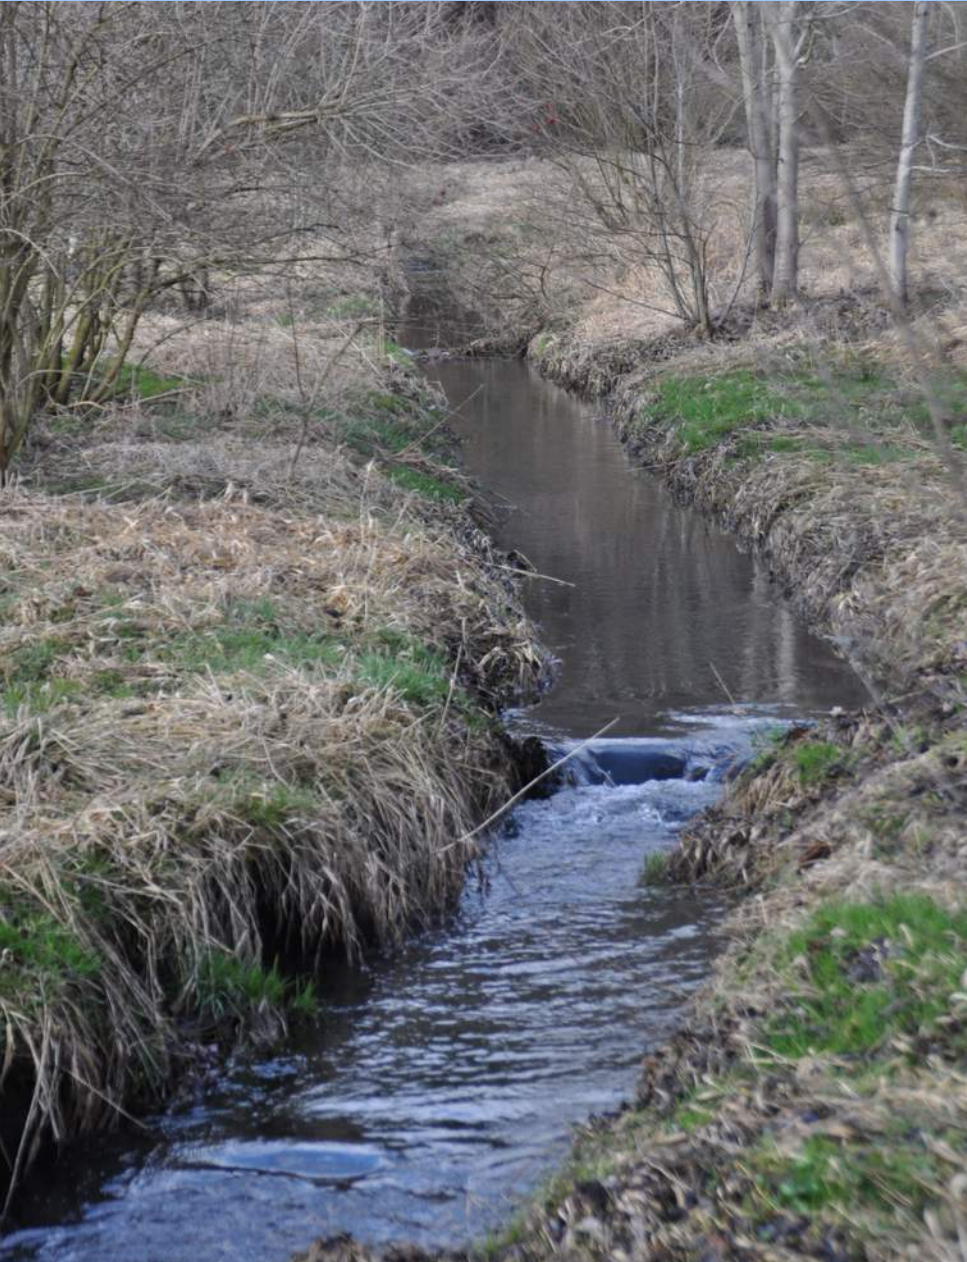
March 2019
A straight part and a following
ramp

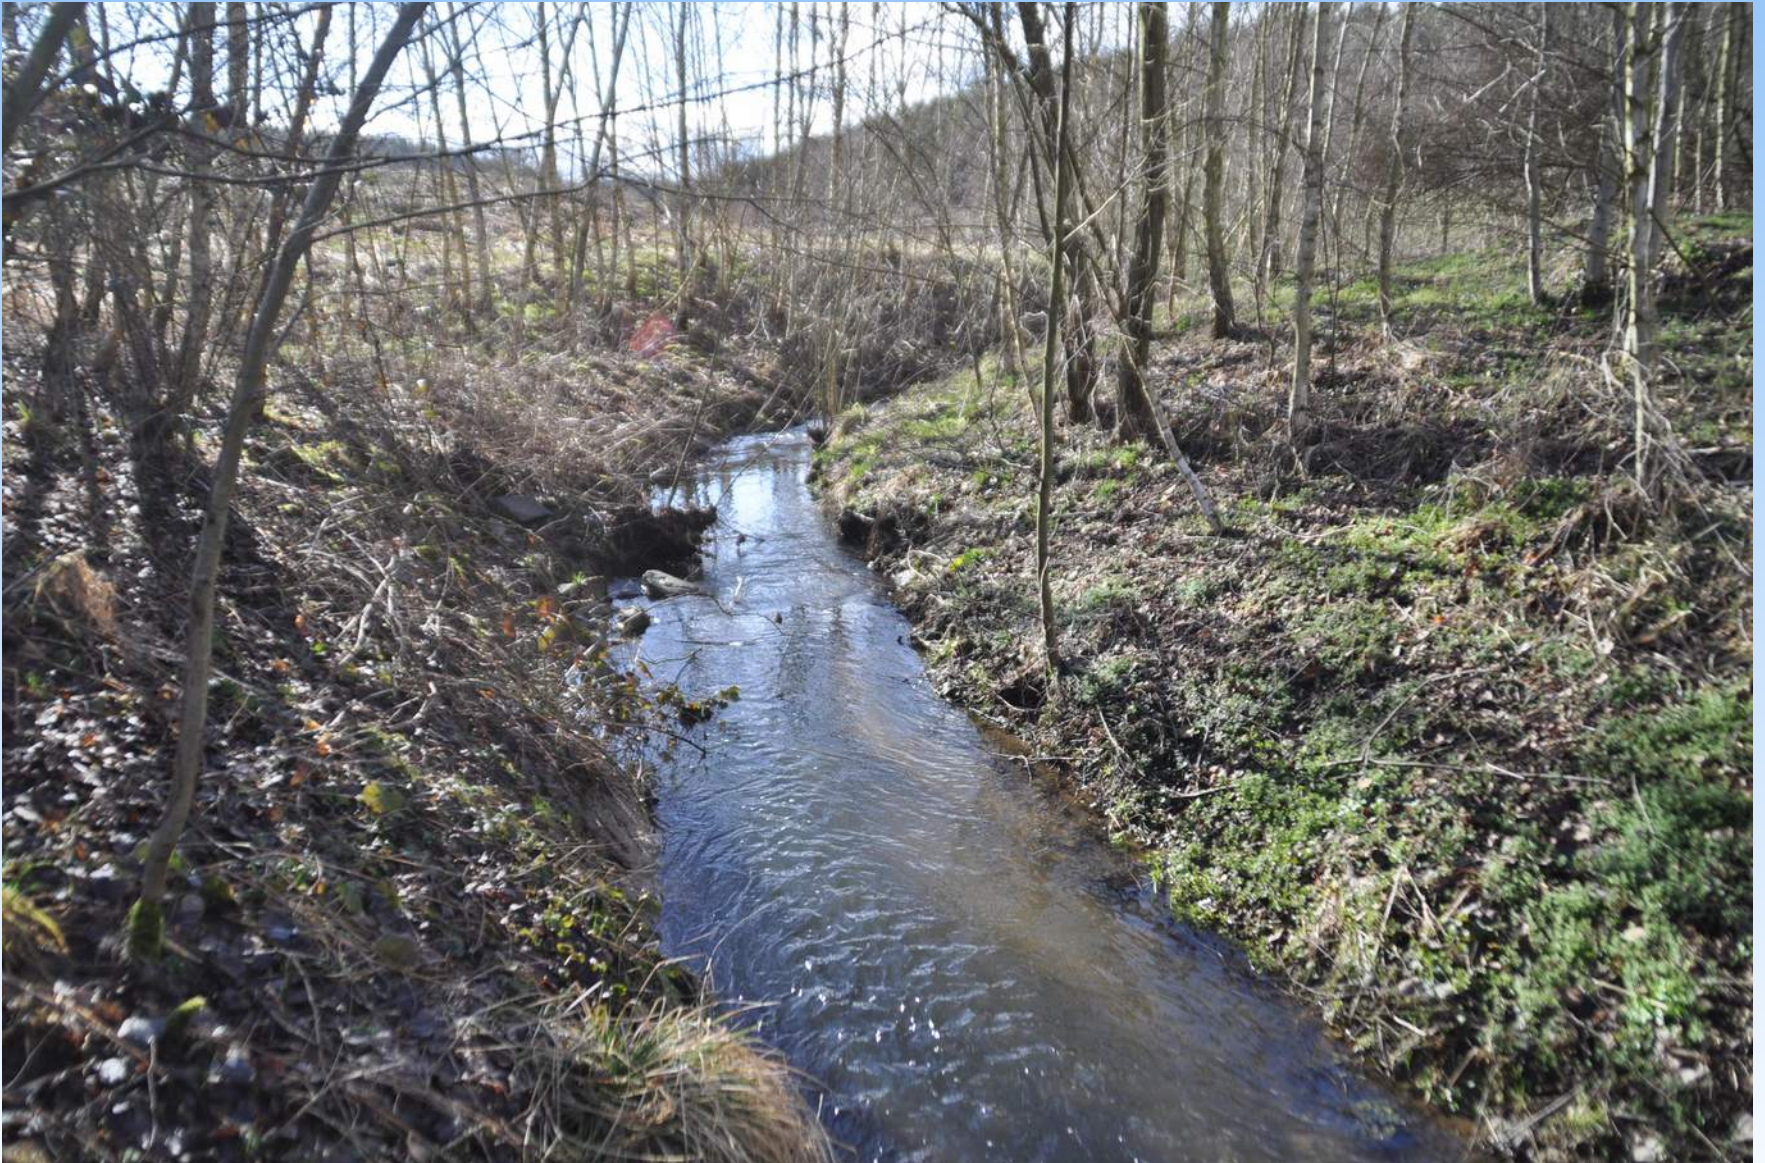
Creek in upper part of the former impoundment – surrounded by forest

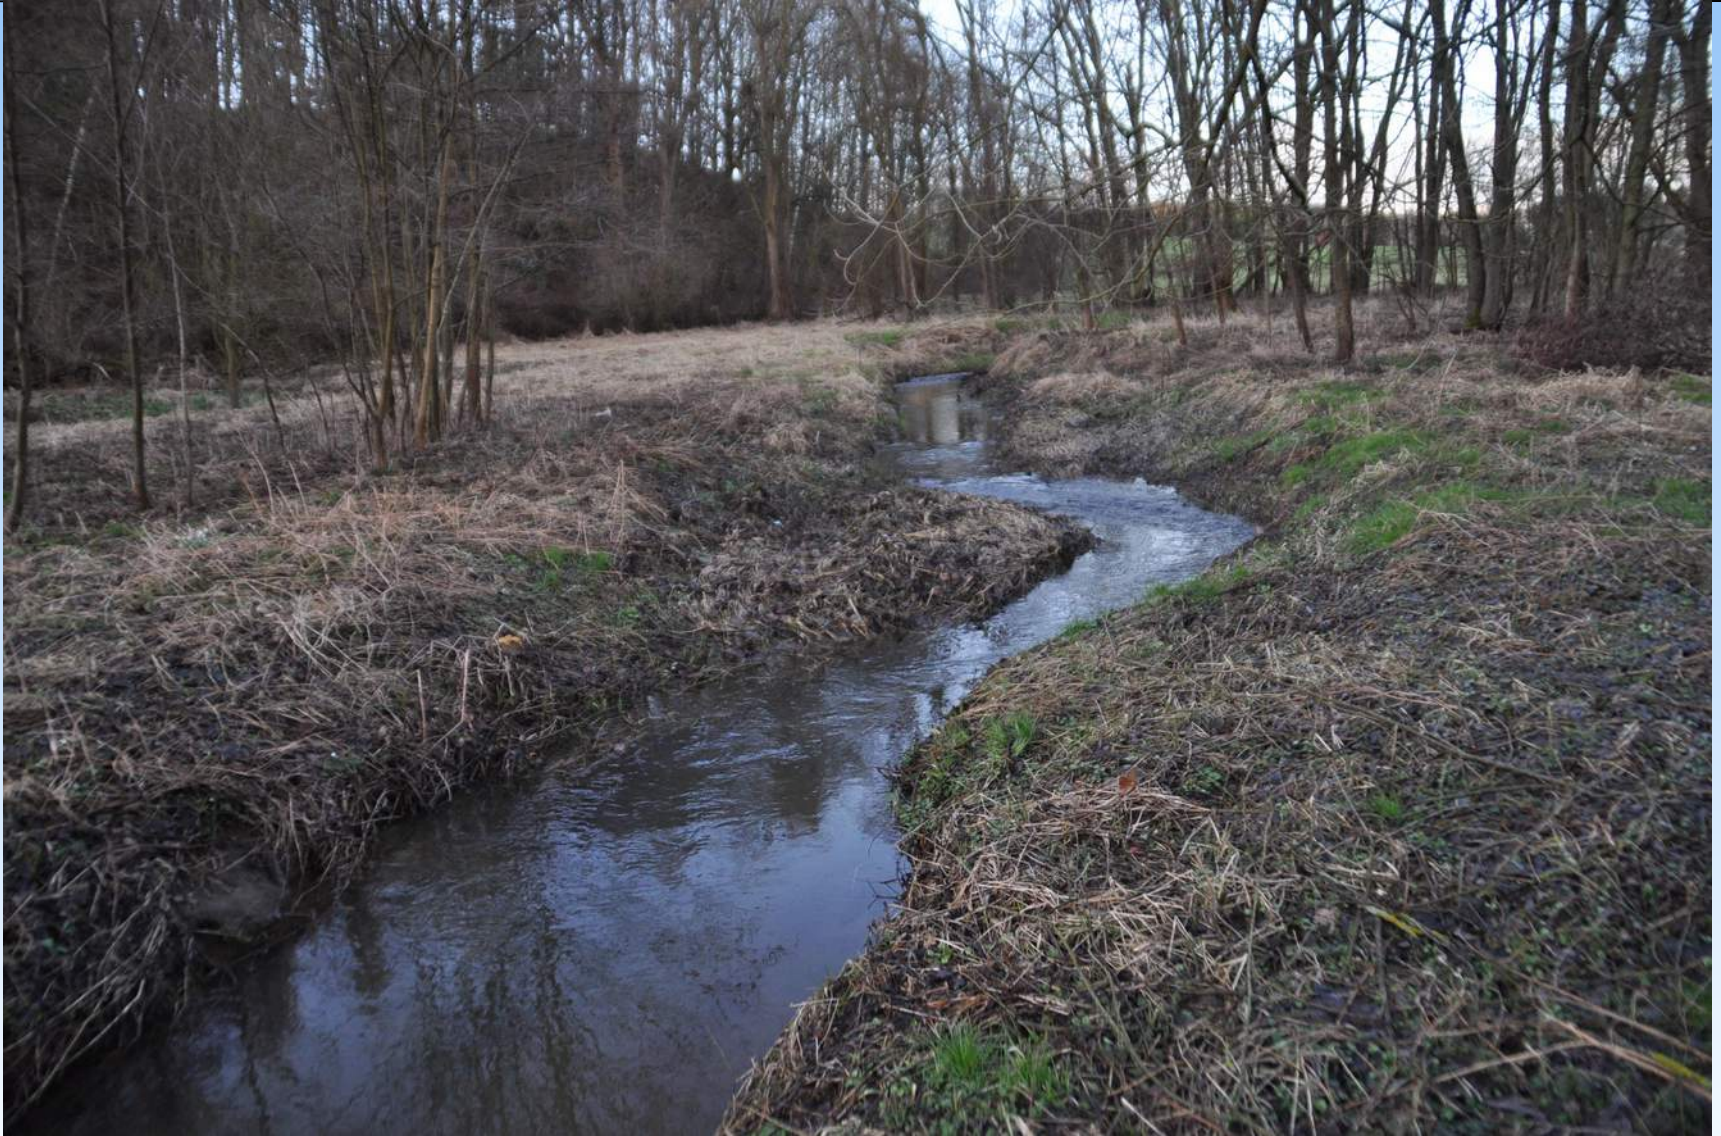
Channel stretch in the upper part, partly disturbed by the flood in 2013

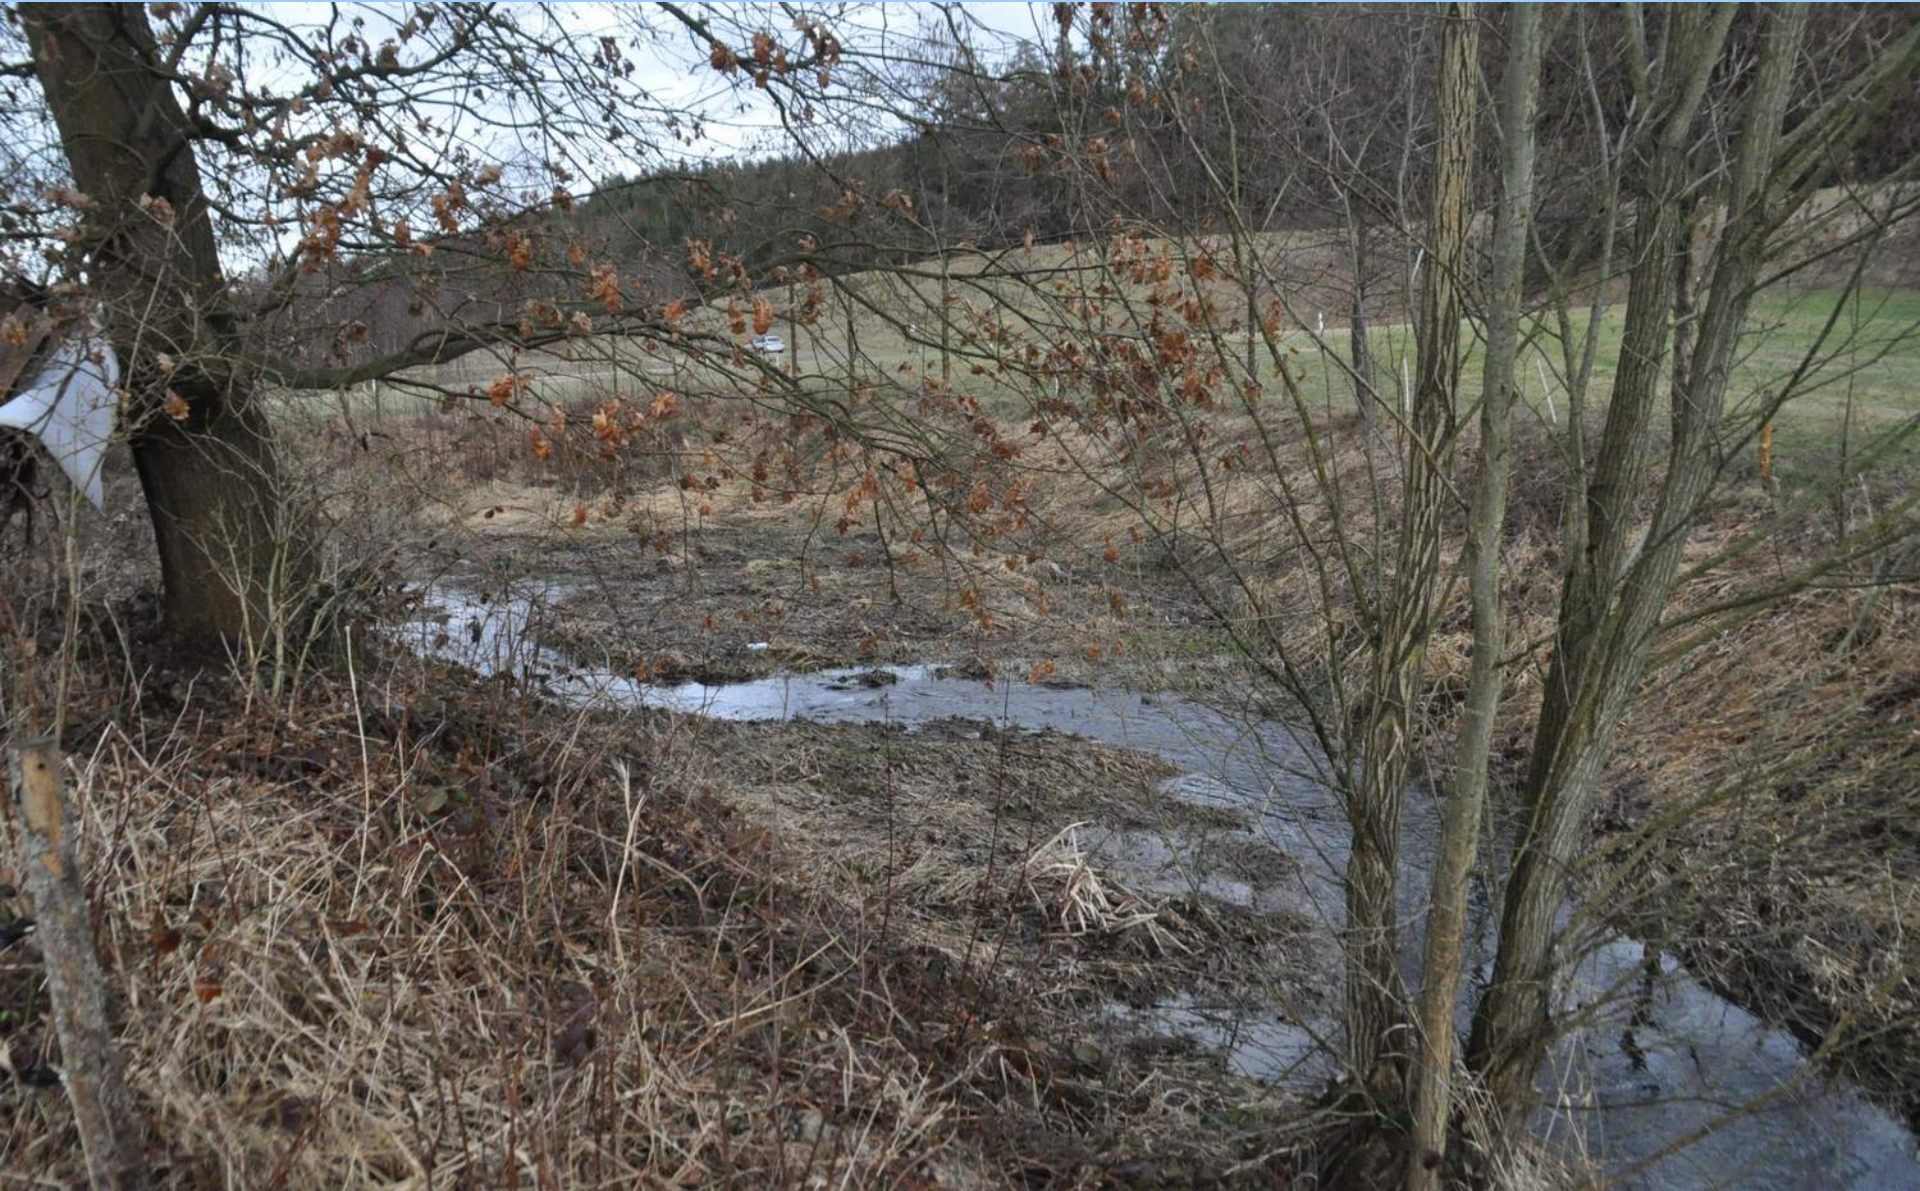
Sediment Pool – downstream of former dam location
