Lessons learned from the removal of the Krebsbach Dam in Germany

Dam Removal Goes Alps 2021, 06.05.2021
Ercan Ayboga

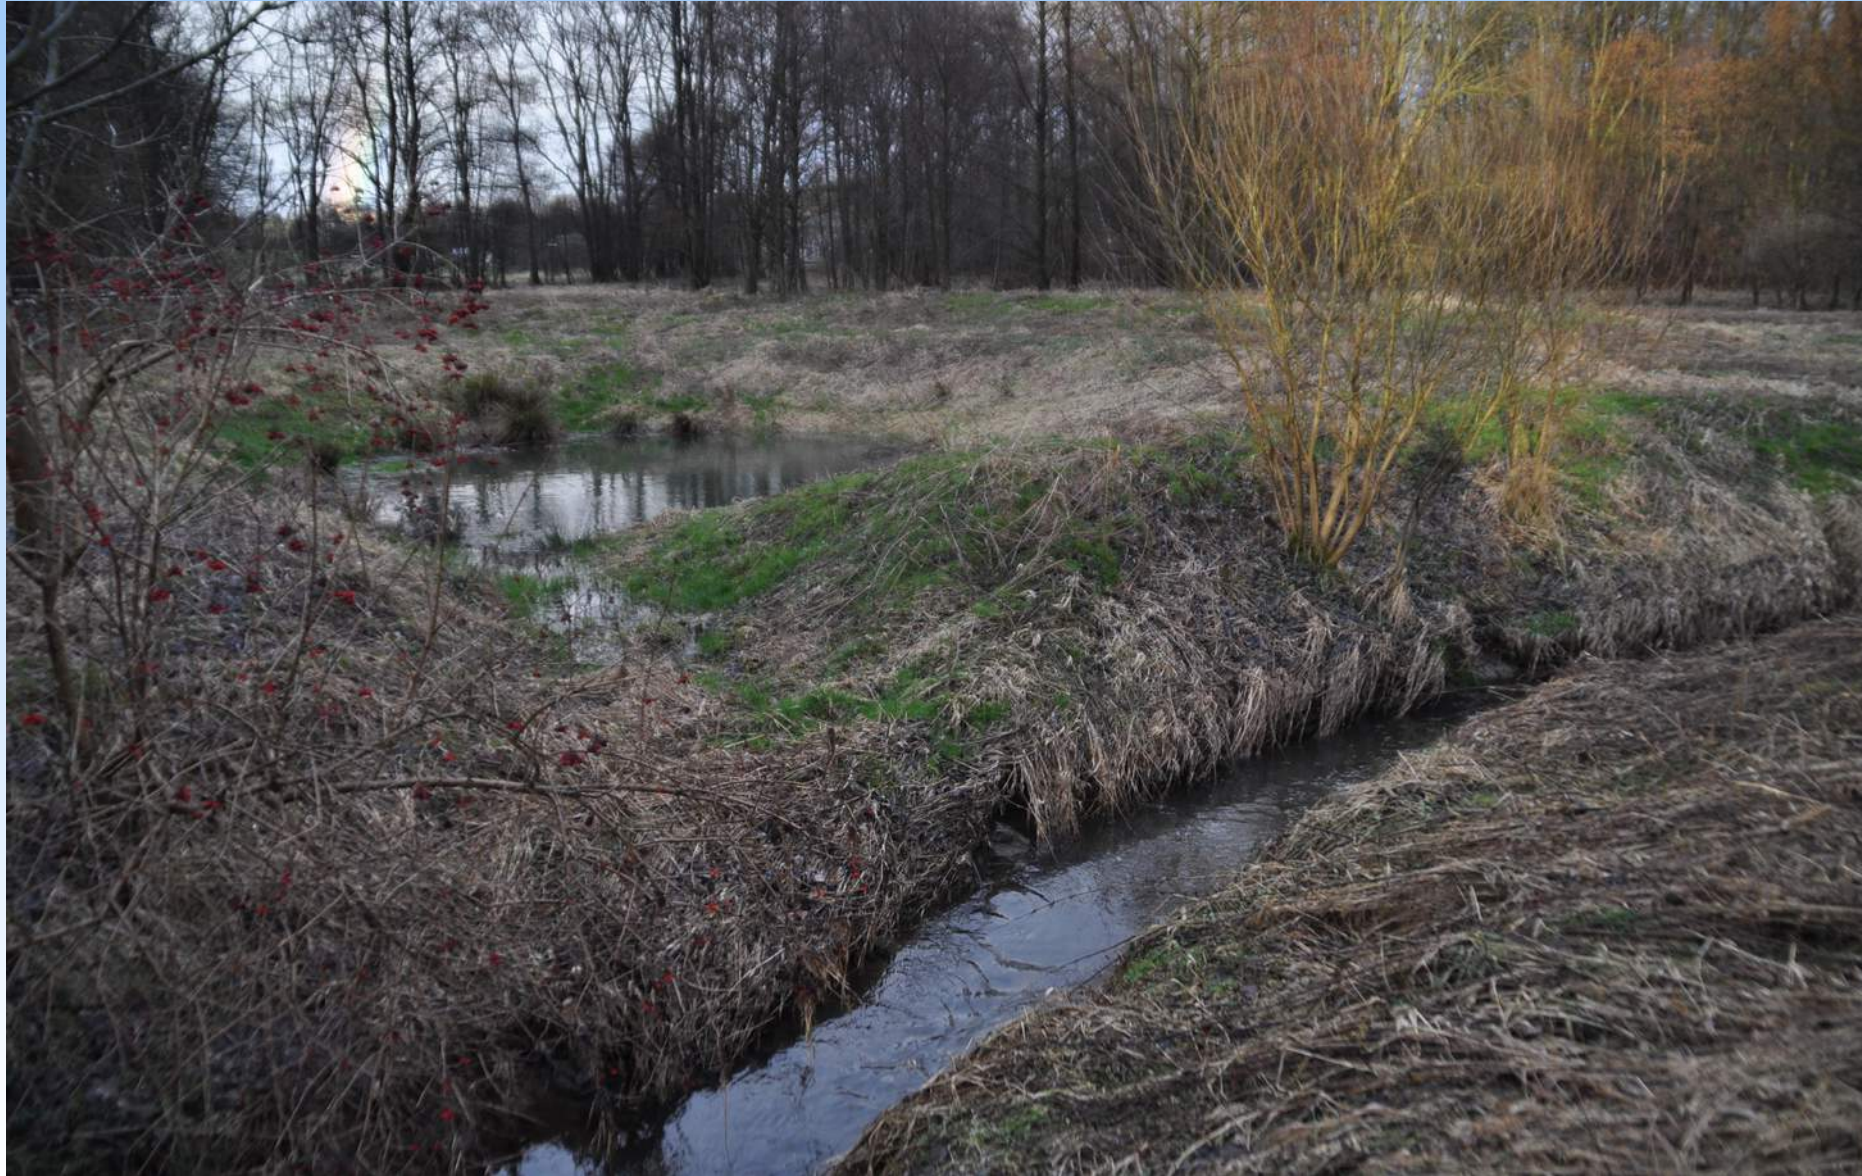
Flood Pool

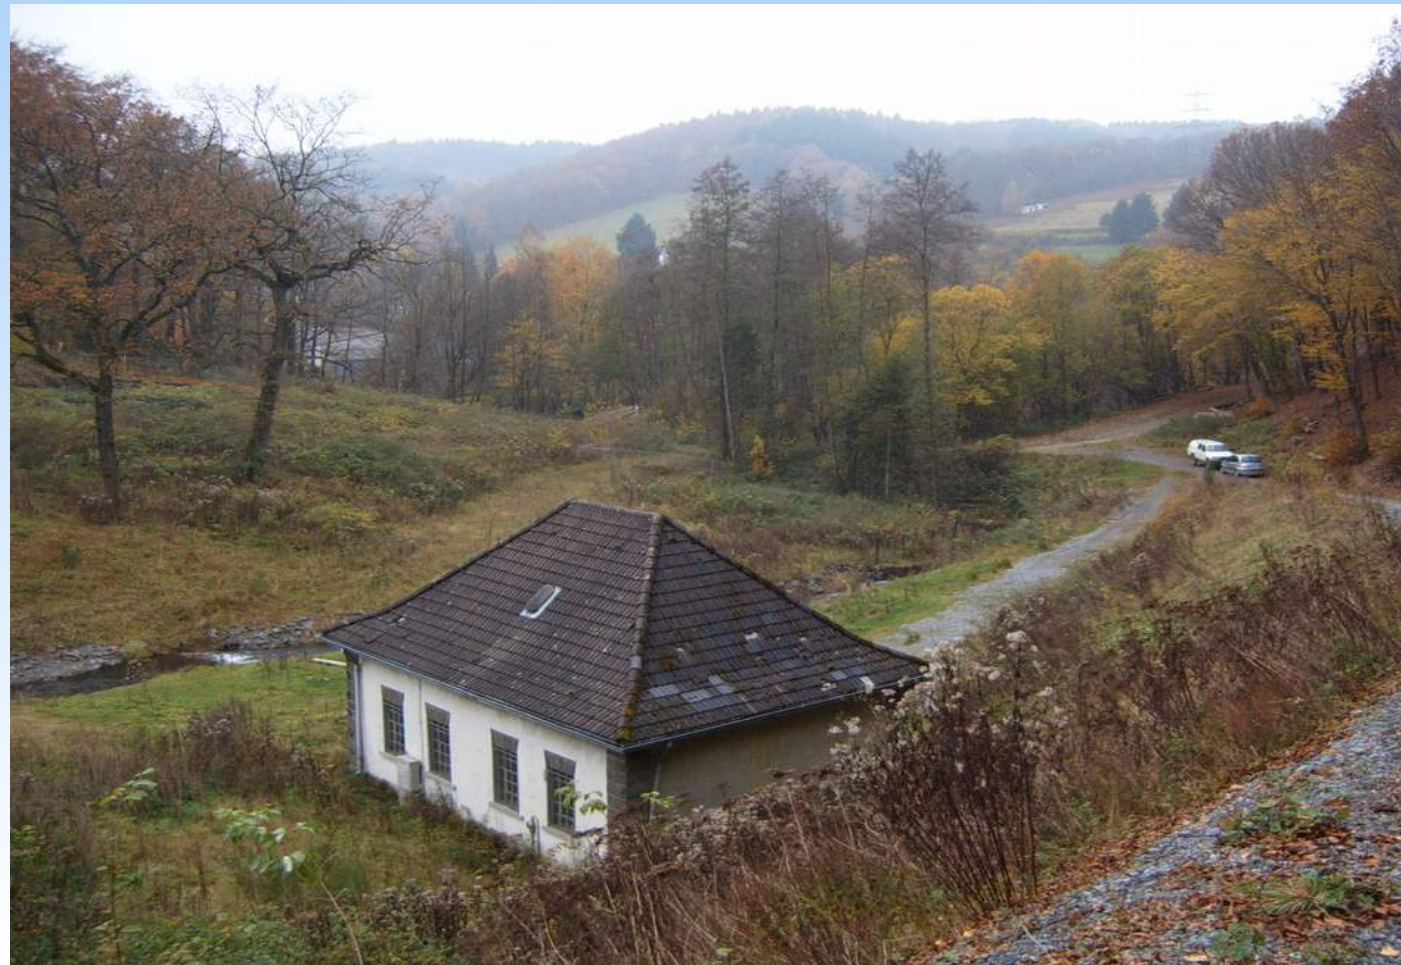
The river channel in the former impoundment has several small cross rows of stones → due to high slope and recreation reasons

200 m downstream is the Wupper River → no flood consideration
