Condition of the weir before the reconstruction in 2010

Reasons for the redesign of the weir

Official Inauguration of the Reconstructed Weir 1 near Lippstadt-Esbeck on 27th June 2012 by District President Dr. Gerd Bollermann

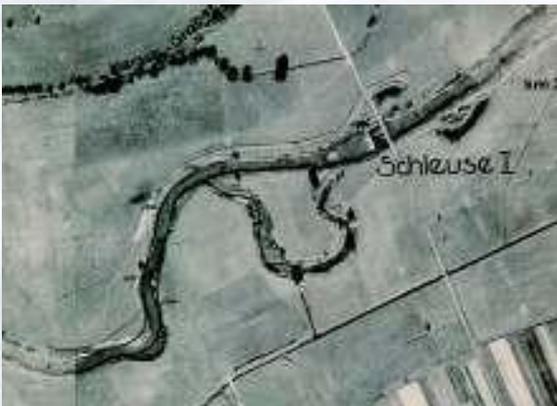
Aerial photo 1927

The location of the original weir and the old course of the river Lippe can be seen.

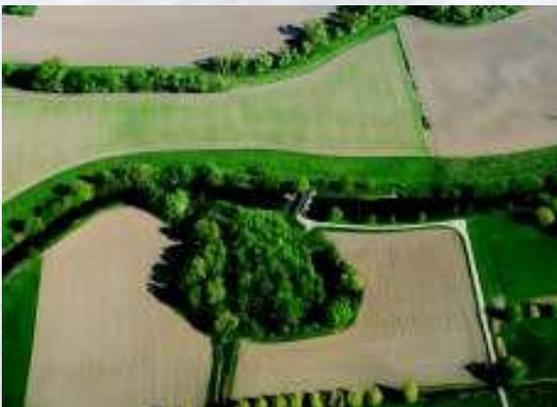
Aerial photo 2008

The photo shows the location of the weir built in 1937 situated directly on the southern arm of the Lippe.

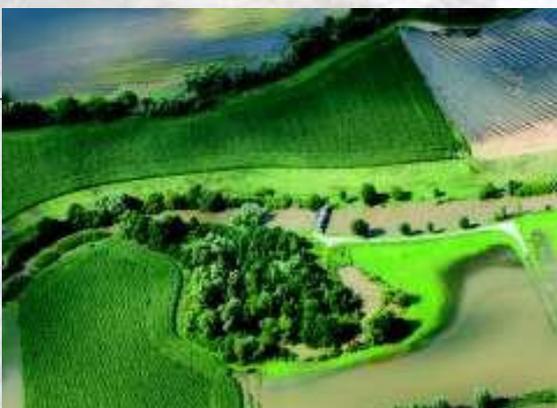
Flooding 2007

Large areas of the inundated floodplain are clearly visible due to the high turbidity of the summer flood.

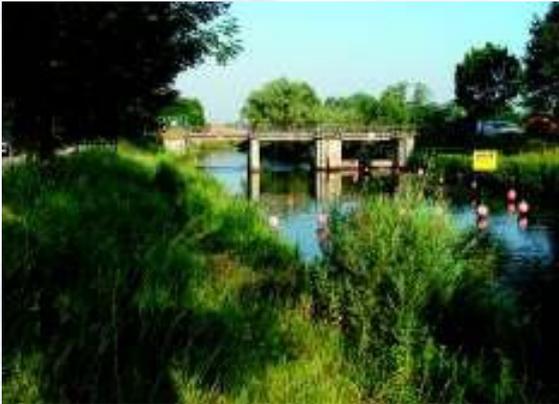
The weir was generally in bad condition. This was one of the reasons why it was decided in 2010 to rebuild the entire complex for the benefit of people and nature.

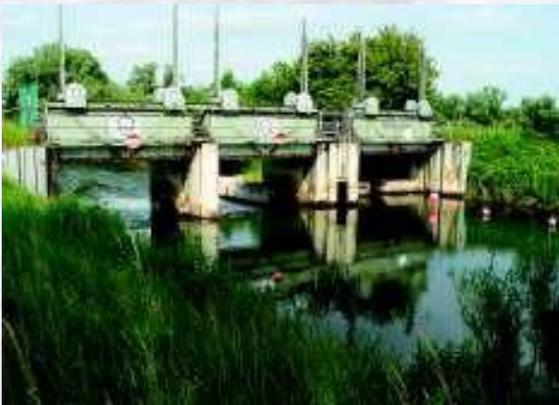
View from upstream

Only one buoy-chain serves to direct boaters. As a result, water sports enthusiasts easily got into the impassable sections of the weir.

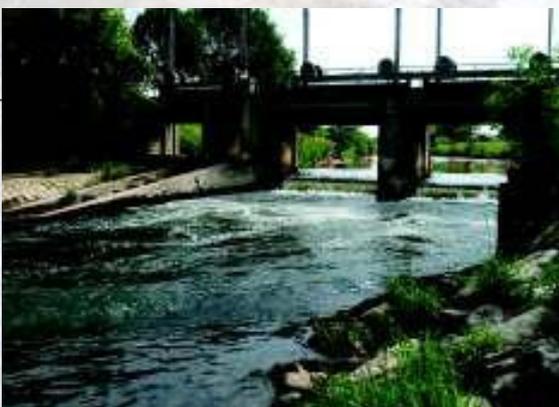
View from downstream

The left section of the weir has a boating lane and fish pass. The middle and right sections are impassable.

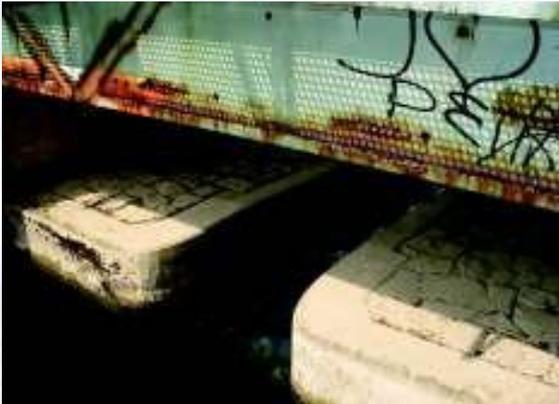
The great need for renovation

The old weir was in need of major refurbishment especially with regard to the steel hydraulics. The weir had not been used for water impoundment for a long time.

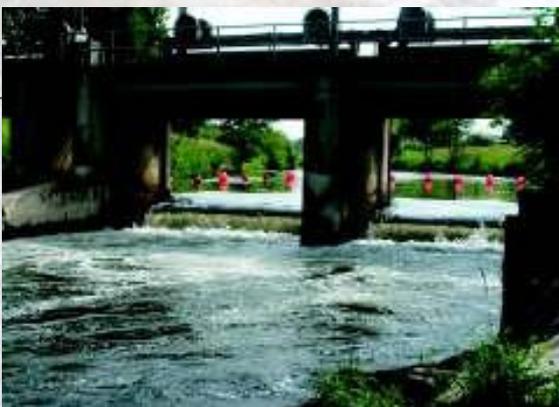
Accident black spot

The dangerous formation of rolling waves had in the past led to several accidents involving water sportsmen. This was another good reason for the reconstruction.

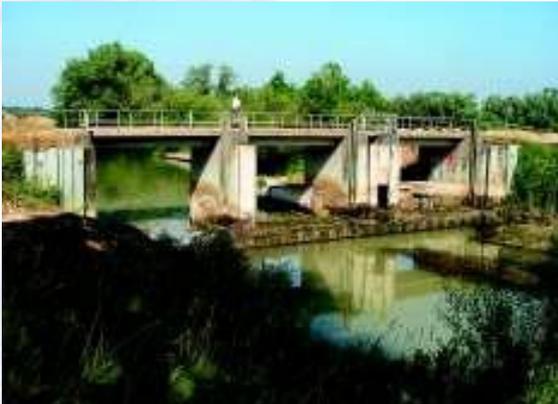
The bridge of the weir after removal of the steel components.

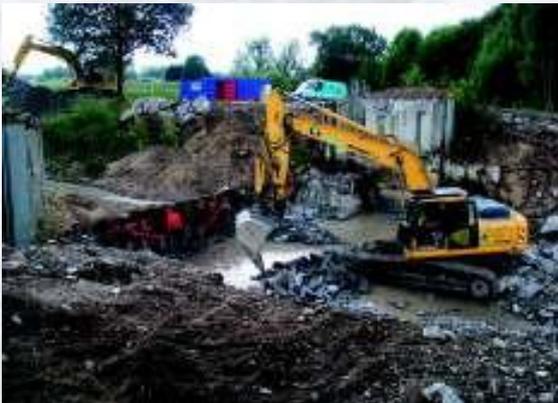
Removal of the weir threshold to the pre-planned level.

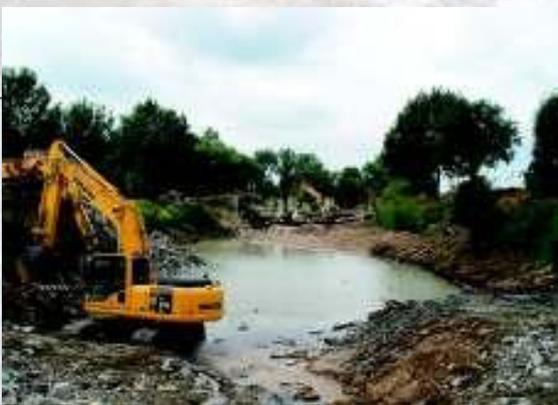
Preparation for the installation of the stone crossbars in the drained riverbed.

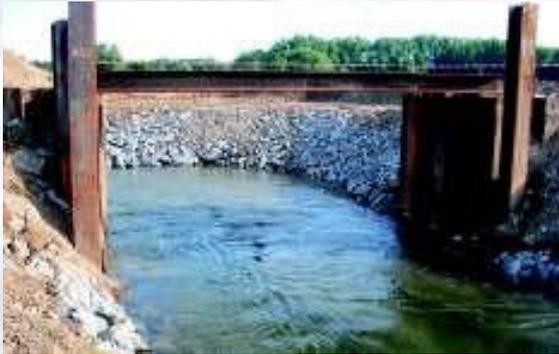
The opening to the bypass channel was built to include the possible installation of a weir gate in case of flooding.

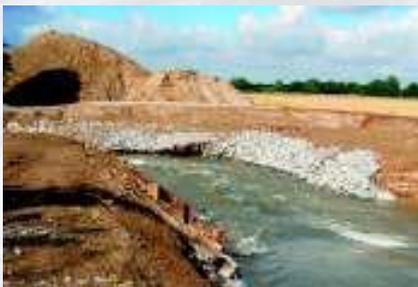
Outlet of the bypass channel with massive rock rubble to protect against scour.

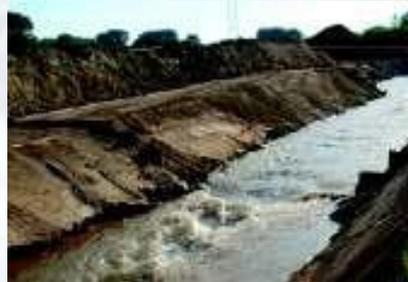
Bypass channel shortly after commissioning.

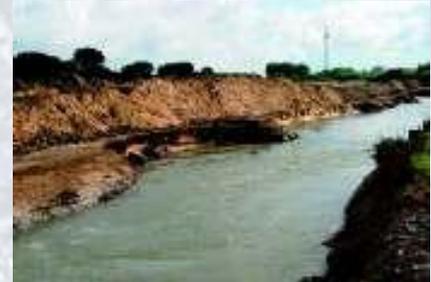
Bypass channel with scouring after two weeks.

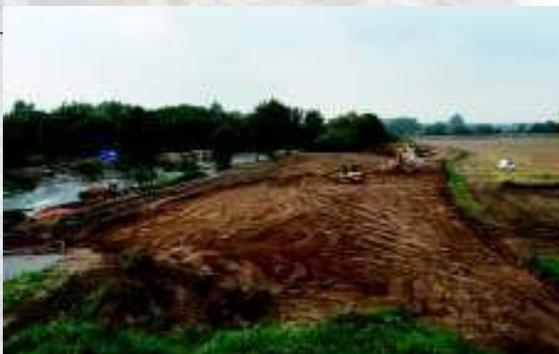
Soil in-filling of the bypass channel after the river had been returned to its original course.

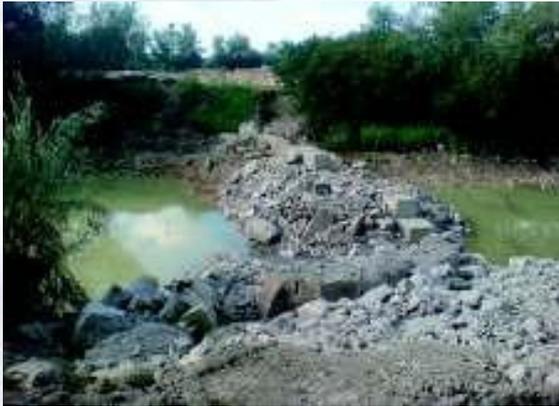
Stone crossbar made from fracture-blasted blocks with frictional bonding.

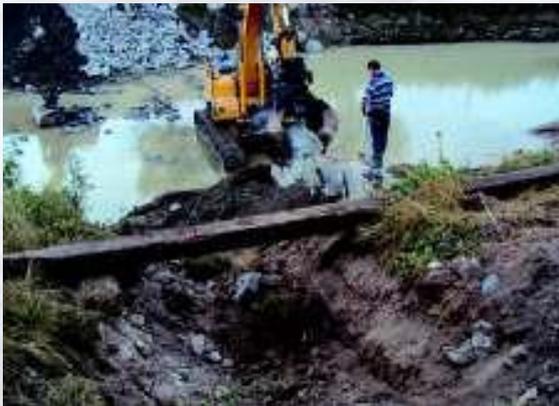
Precisely-calibrated installation of the individual blocks.

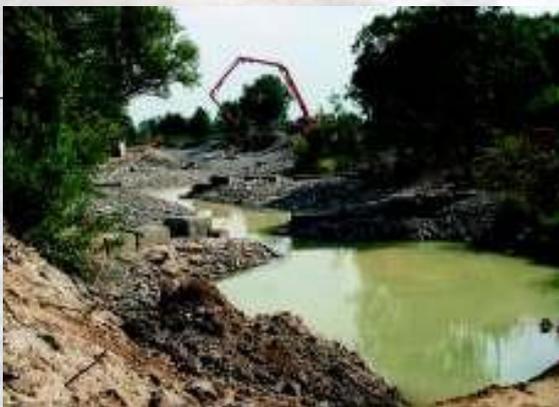
Finished crossbars in situ on the riverbed.

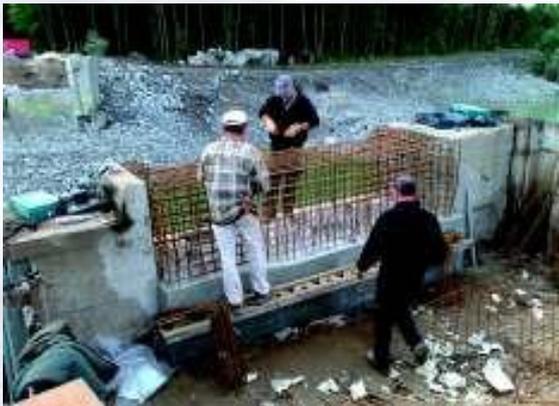
Renovation and adaptation of bridge abutments.

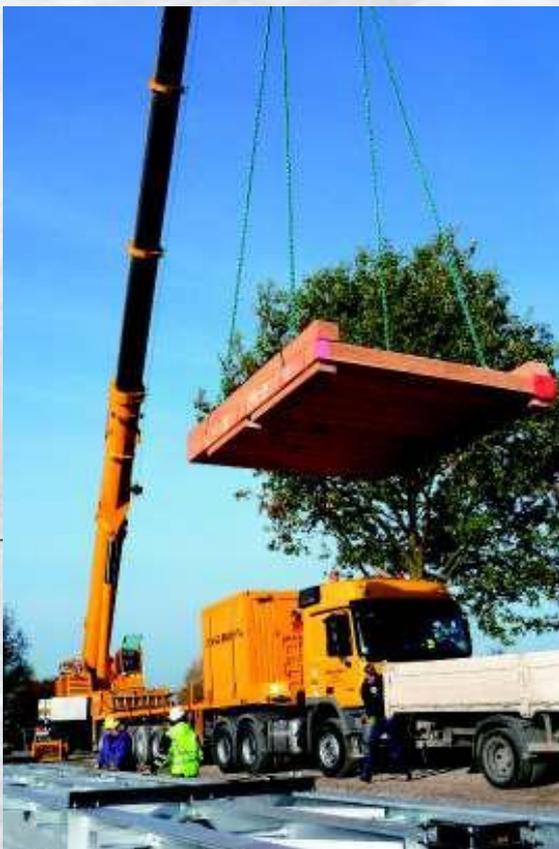
Fitting the new bridge superstructure.

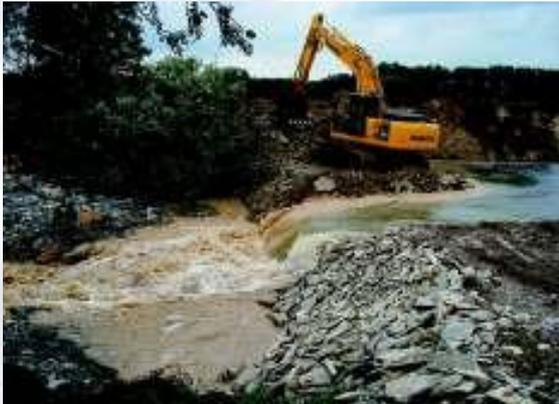
In August 2010 the time had finally come. The construction work was largely completed, the protective barriers could be cleared away and the river returned to its normal course.
